## **A Career Captain Dies and a Fire Fighter/Driver is Seriously Injured When Two Fire Trucks Collide at an Intersection – Connecticut**

### **SUMMARY**

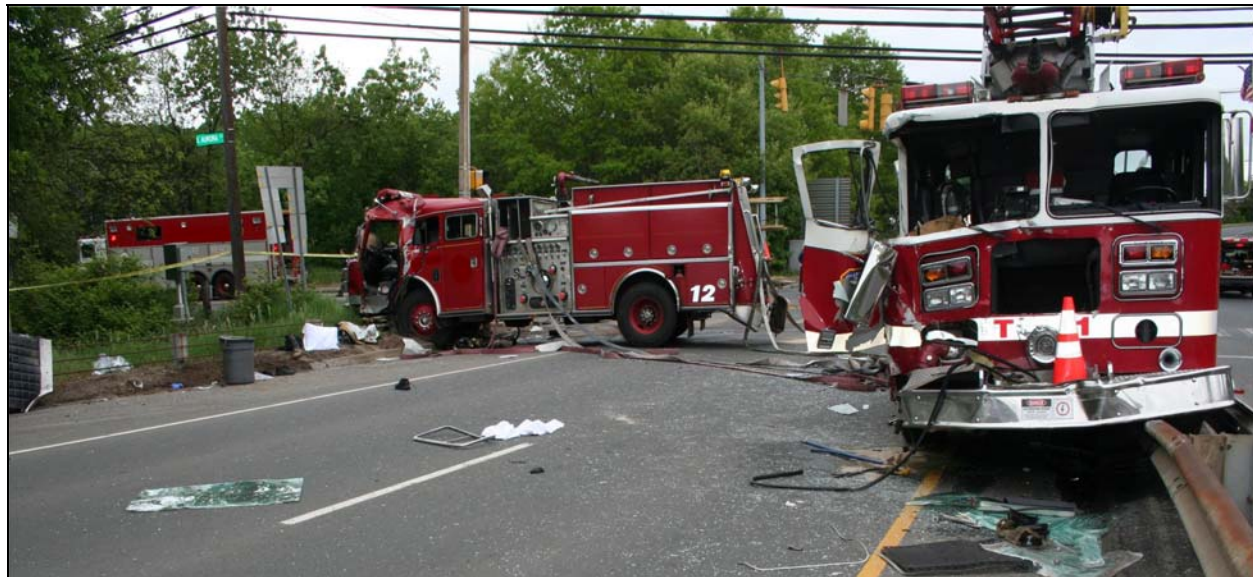
**Final location of apparatus following the collision**  
*(Photo courtesy of the fire department)*

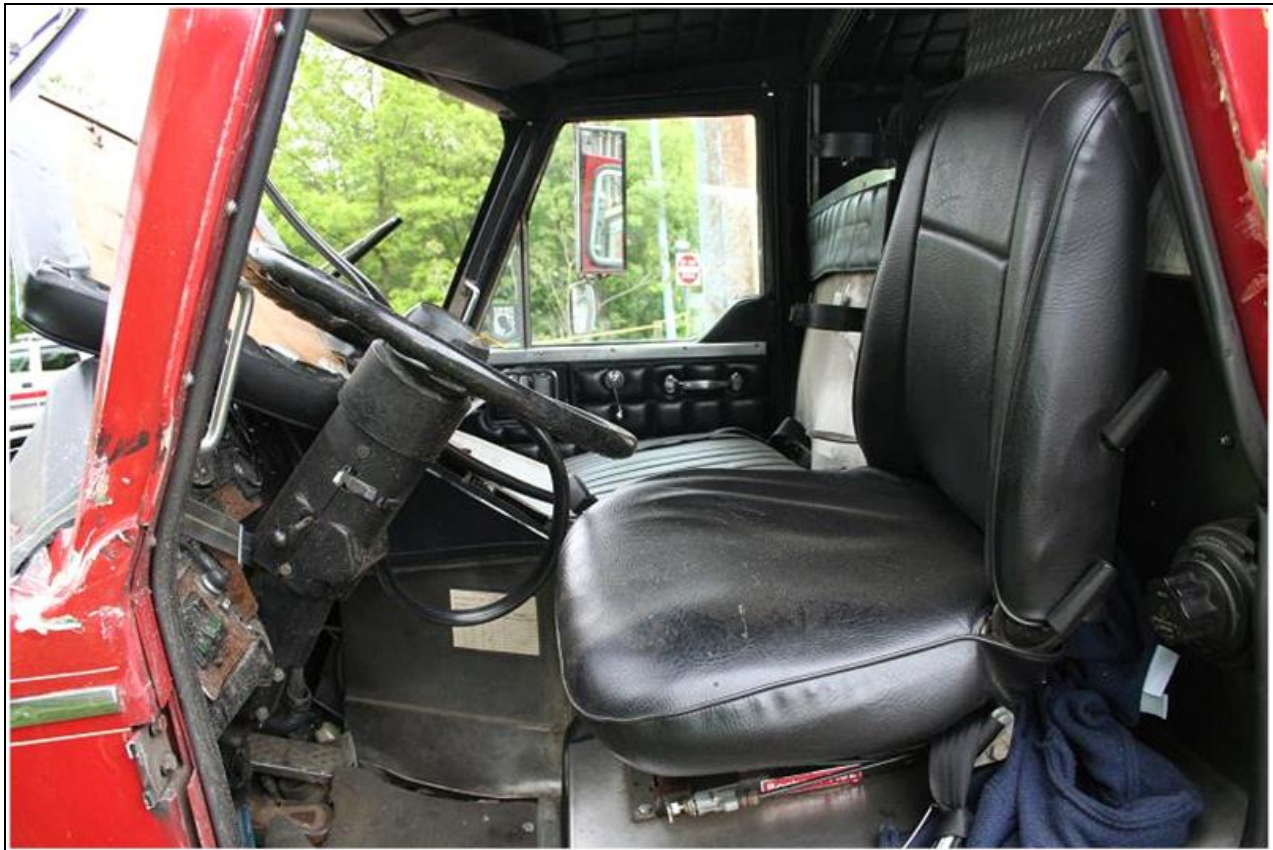
During the collision, E12 sustained heavy impact damage to the left front portion of the cab which bore the brunt of the collision. The driver's door was completely detached from the cab. The right side passenger doors remained correctly positioned and functional. Both safety glass sections of the front windshield were broken out of the frame, but the center support column remained fixed. The driver's seat remained connected to the metal pedestal floor support, but was bent slightly forward and down to the left. The officer's bench seat had broken free from its anchors and was not equipped with an integrated self-contained breathing apparatus (SCBA) seat bracket.<sup>a</sup> According to the police report, both the driver's and the officer's seats were equipped with seat belts which appeared to be in good working order. An independent inspection, conducted by a nationally recognized consulting firm specializing in seat belt inspections, verified the police findings (**Photo 1**).

**Photo 1. Engine 12 cab interior viewed from the driver's side.**  
*(Photo courtesy of the fire department)*

***Recommendation #2: Fire departments should enforce SOPs that require mandatory use of seat belts in all vehicles.***

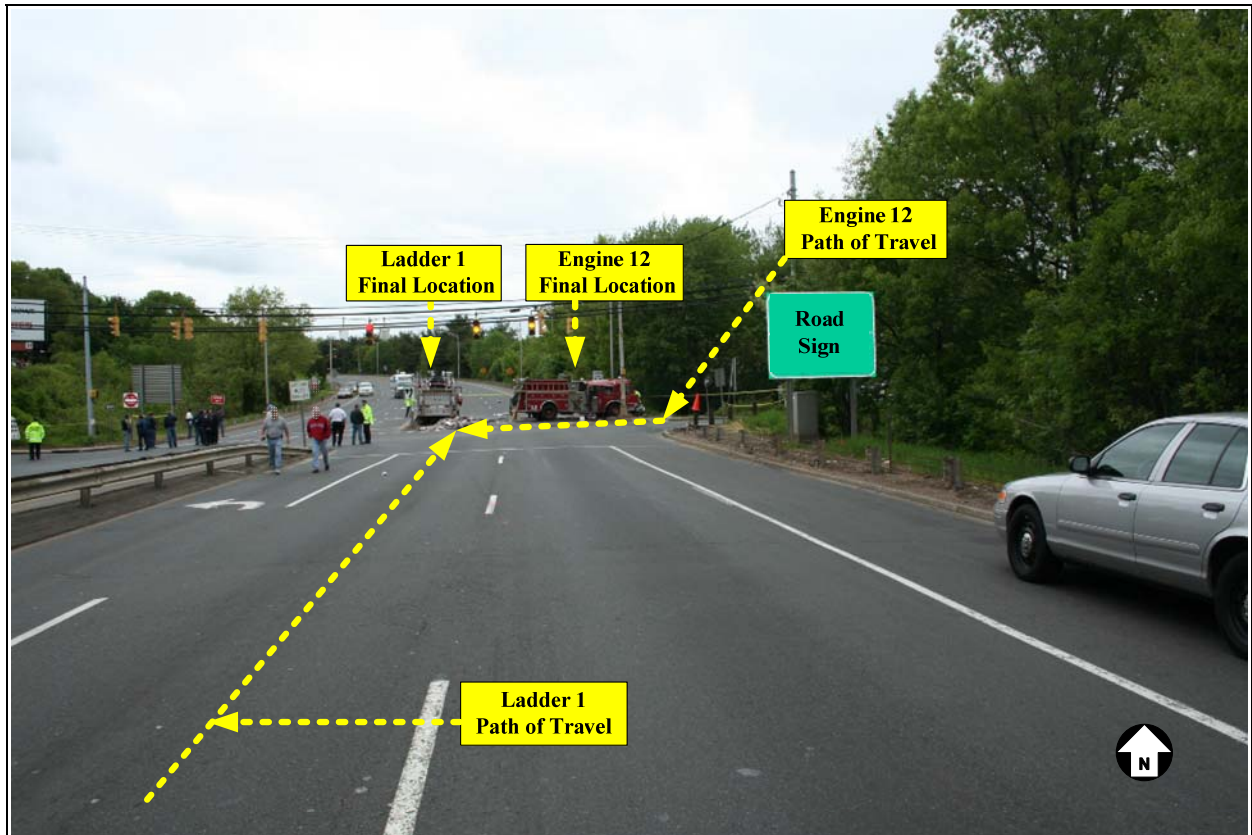
more time to react and slow their forward motion, thereby lessening the force of the impact or possibly avoiding the collision all together (Photos 2 and 3).

Discussion: Line-of-sight for motorists is one of the most important safety issues at an intersection. The ability of drivers to be able to see approaching traffic to determine if it is safe to enter the intersection is critical. According to the State Highway Design Manual, which is issued by the state where the incident occurred, “traffic signals should not be an alternative to providing adequate sight distance.”<sup>14</sup> Areas along the approach to an intersection and across the corners should be clear of obstructions that might block the driver’s view of approaching traffic. In this incident, line-of-sight at the intersection was severely obstructed by tree foliage and although there is no evidence this directly caused the collision, the obstructed view likely prevented the drivers from seeing each other thereby causing a delay in their reaction time to the impending collision (Photo 2, Diagram 3).

**Photo 2. Showing the apparatus path of travel, final location after collision, and trees that created a line-of-sight obstruction, as viewed facing north.**  
*(Photo courtesy of the fire department)*

***Recommendation #5: Governing municipalities (state, regional, local) should ensure that adequate line-of-site is maintained at roadway intersections, with an emphasis on routes routinely traveled by responding emergency vehicles/apparatus.***

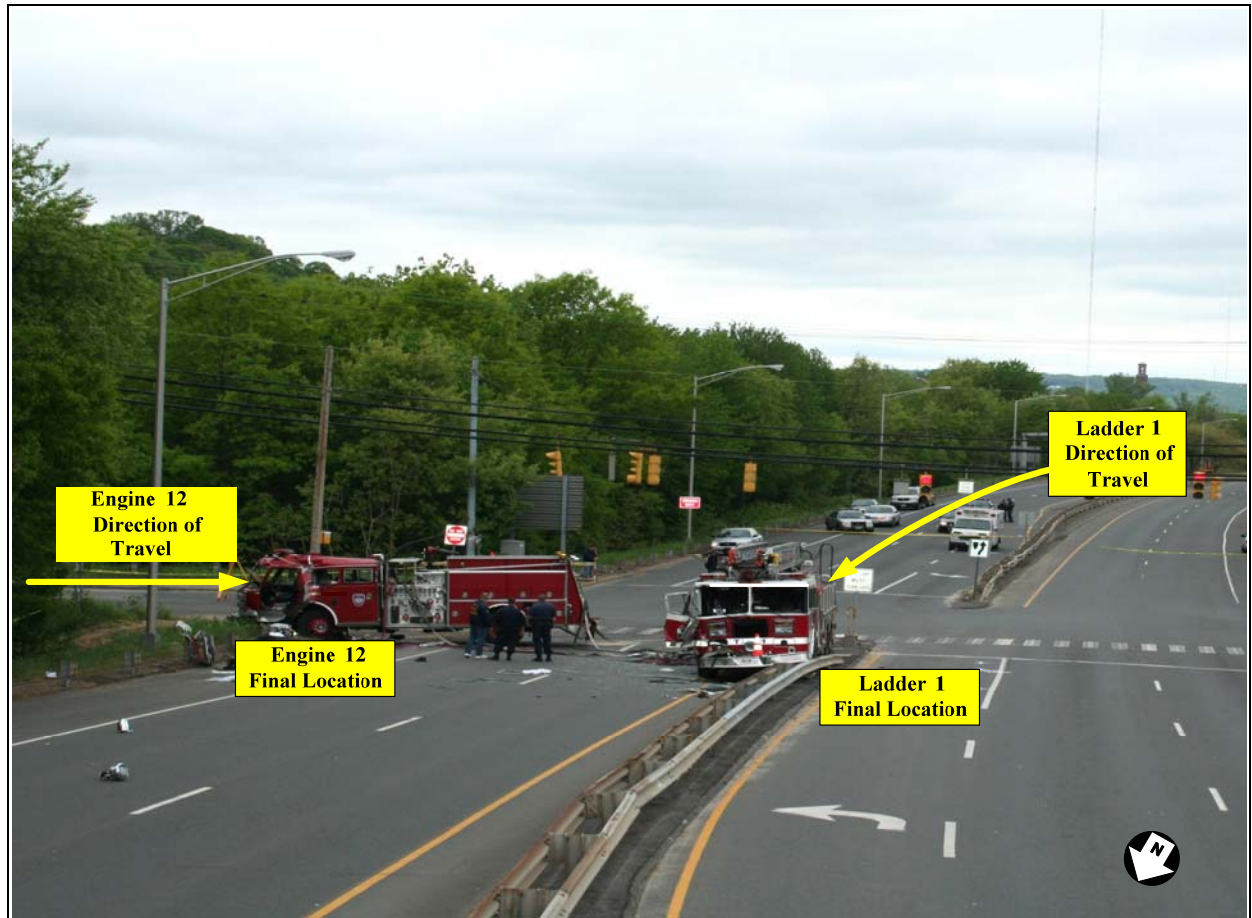
**Photo 3. Apparatus direction of travel and final location after collision  
As viewed from the north facing south.  
(Photo courtesy of the fire department)**

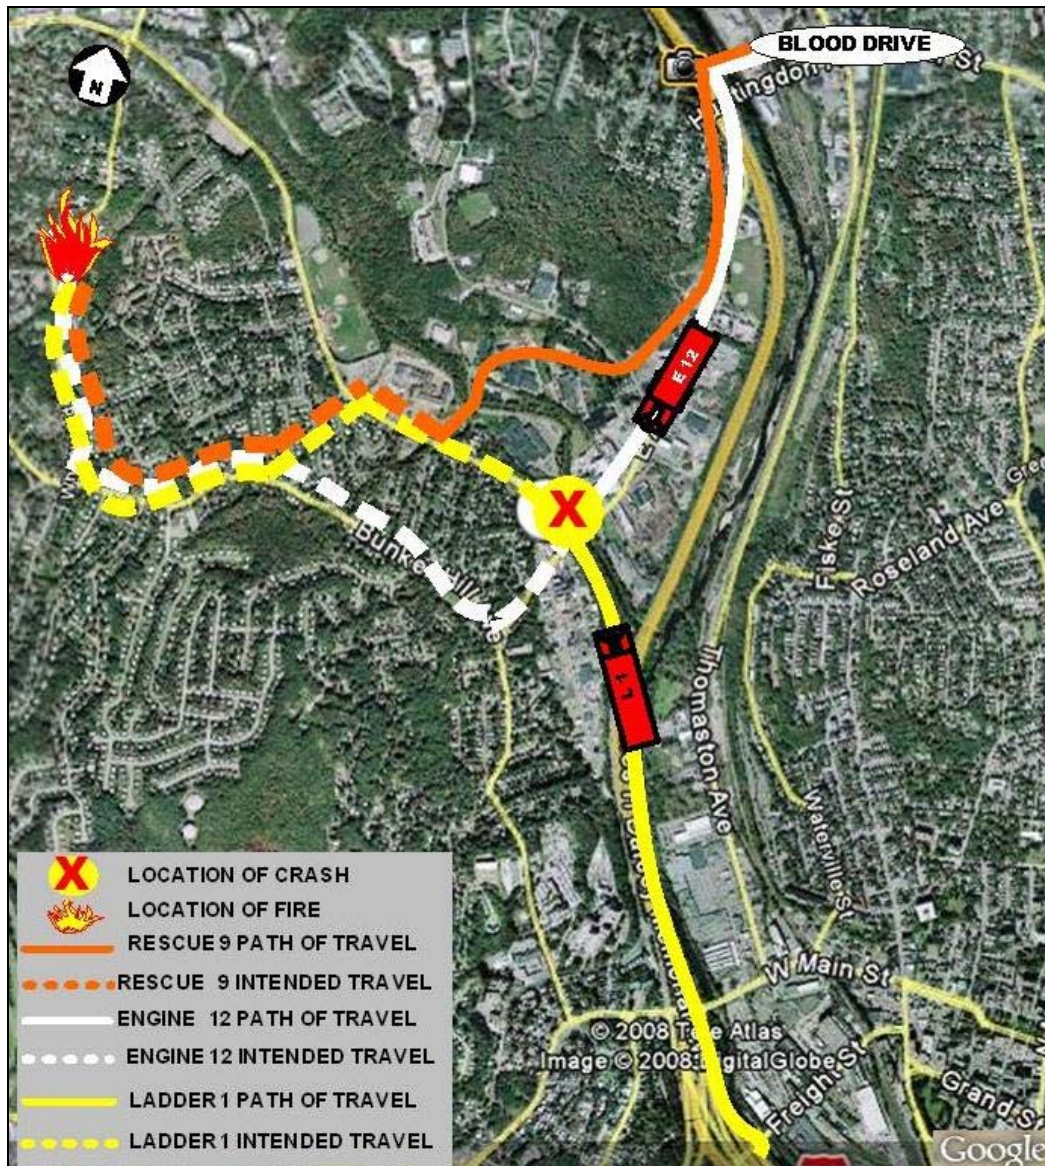
according to the police report, was about 4/10 of a mile shorter in distance. Engine 10, with a driver/operator, an officer, and two fire fighters; a department sport utility vehicle (SUV) driven by a Deputy Fire Chief; and Ladder 1, with a fire fighter/driver, an acting officer, and two fire fighters were dispatched to the reported fire location and responded from their station which was south of the crash scene ([Diagram 1](#)).

**Diagram 1. Aerial view depicting path of travel for L1, E12 and R9  
(Aerial view Google Earth)**

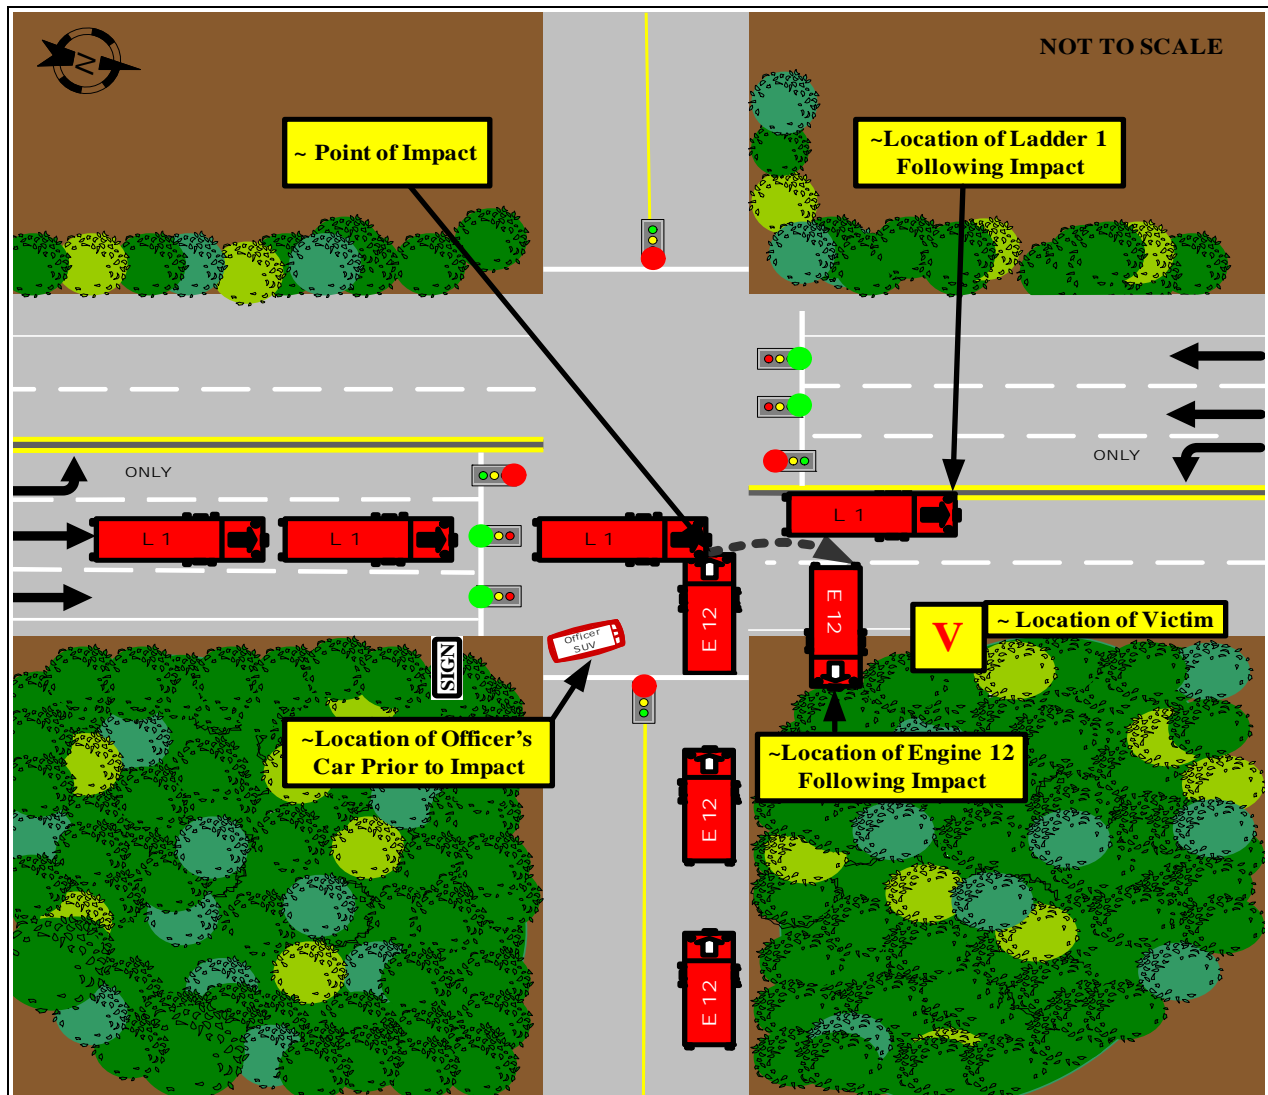
**Diagram 2. Aerial view depicting traffic signals, trees restricting visibility, apparatus progression, point of impact, and final location of victim and apparatus.**

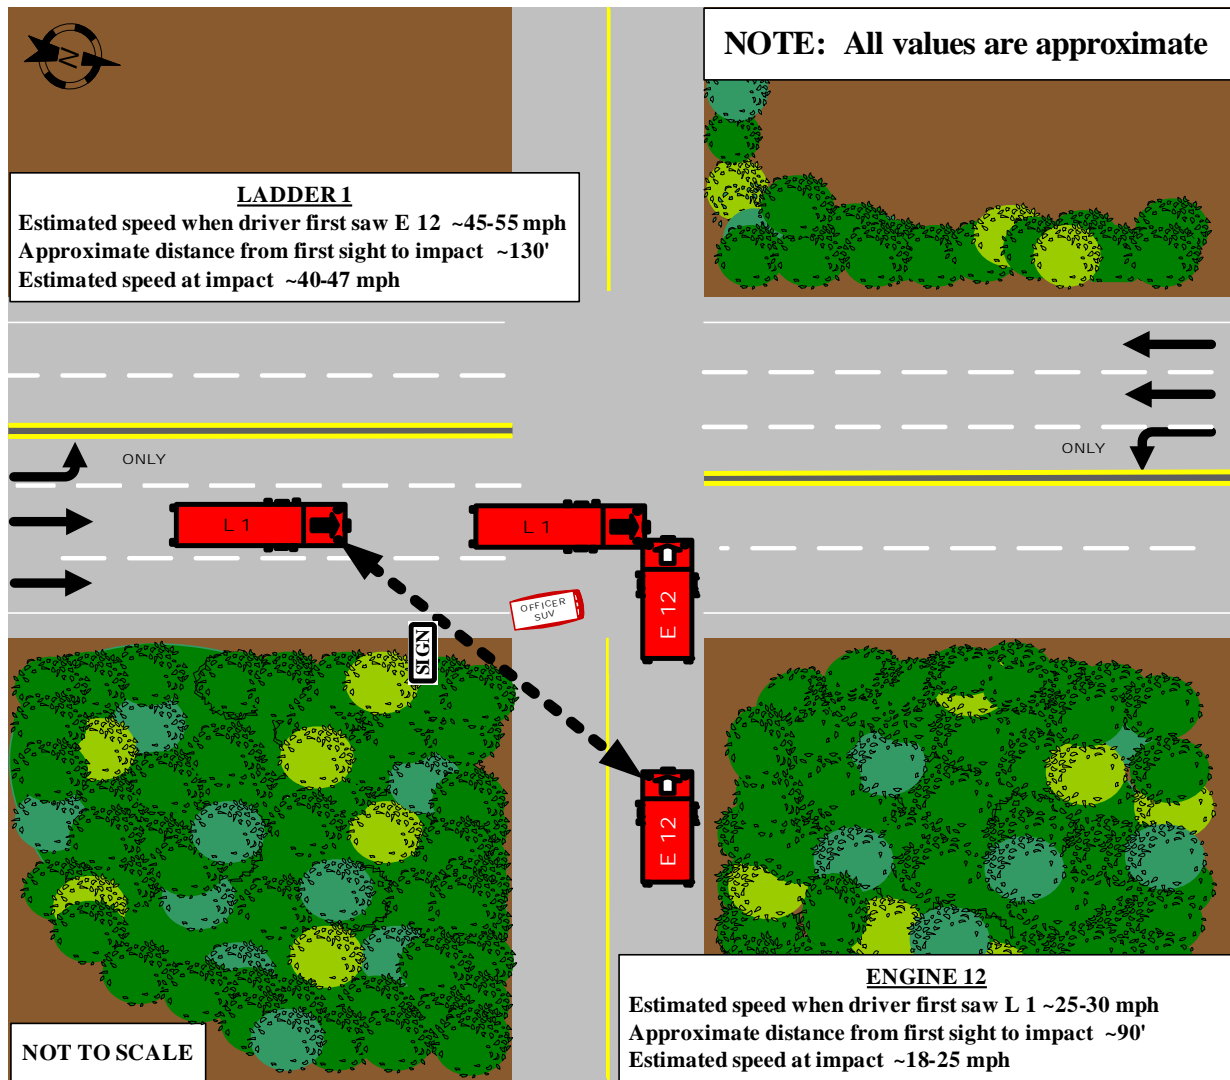
**Diagram 3. Aerial view depicting line-of-sight and approximate location of apparatus at first sight.**

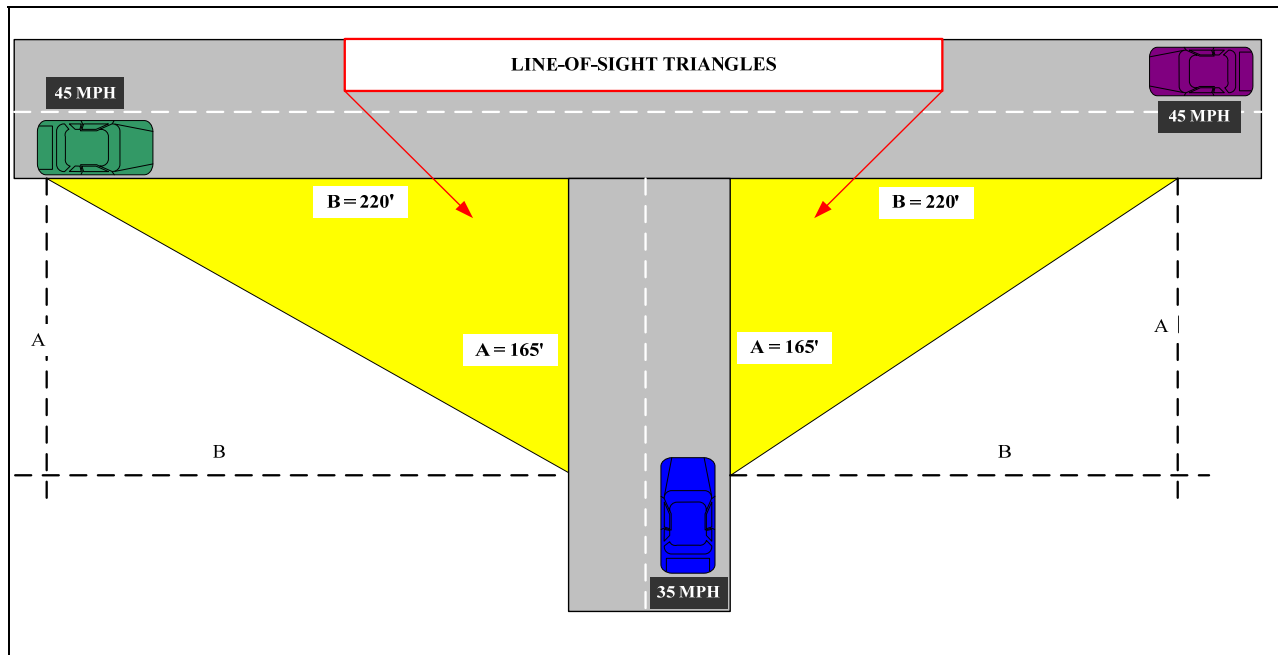
**Diagram 4. Depiction of calculations used to determine intersection line-of-sight. Sight distances are determined based on obstructions, vehicle speed, and road geometry. A and B are pre-determined stopping distances.**

**Intersection Line-of-Sight Distance  $\geq$  Stopping Sight Distance**
