A Career Lieutenant and a Career Fire Fighter Found Unresponsive at a Residential Structure Fire – Connecticut

Executive Summary

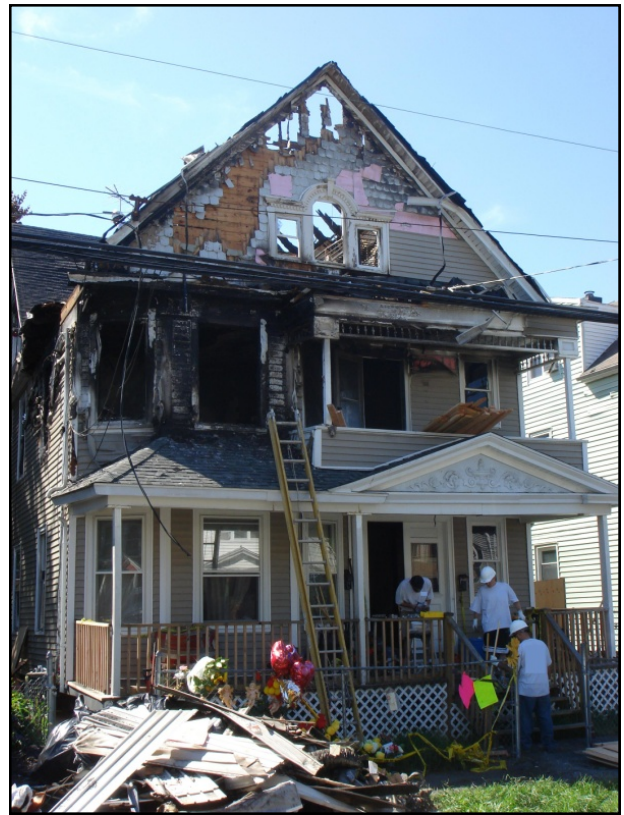
Built in the early 1900s, the two-and-half-story house (see Photo 1) was purchased approximately 4 years prior to the incident as a multifamily rental occupancy. One family lived in the 1st floor apartment (approx. 1,300 sq. ft.); a second family lived in the 2nd floor apartment (approx. 1,300 sq. ft.) (See Diagram 2), and the owner occupied the finished half-story or attic space (approx. 700 sq. ft.) (See Diagram 3). The house also contained an unfinished basement (approx. 1,300 sq. ft.). The common front entrance contained access to the 1st floor apartment and a private stairwell, located at the A/D corner of the house, which provided access to the 2nd floor apartment. The house also had a single rear-entry door that provided access to a stairwell that led up to the owner's apartment and had landings to access all the apartments from the rear. According to the owner of the house, smoke detectors were installed within the house about a year prior to the incident. These smoke detectors were installed in every bedroom, in each hallway, and in the stairwells. The house did not have an installed sprinkler system and had been inspected in accordance with Department of Housing and Urban Development Section 8^a guidelines, according to the homeowner. The house was Type V wood frame construction, but, during the initial stages of the fire, was presumed by arriving fire fighters to be balloon-framed due to the era when it was constructed. State fire investigators were able to confirm Type V construction after closer inspection.

**Photo 1. A-side of house during cleanup operations.
(NIOSH photo.)**

The Office of the State Fire Marshal's building code compliance inspection showed that the house did not meet certain Connecticut Fire Safety Code requirements for this type of structure. NIOSH investigators do not believe that these non-compliance issues contributed to the deaths of the two fire fighters.

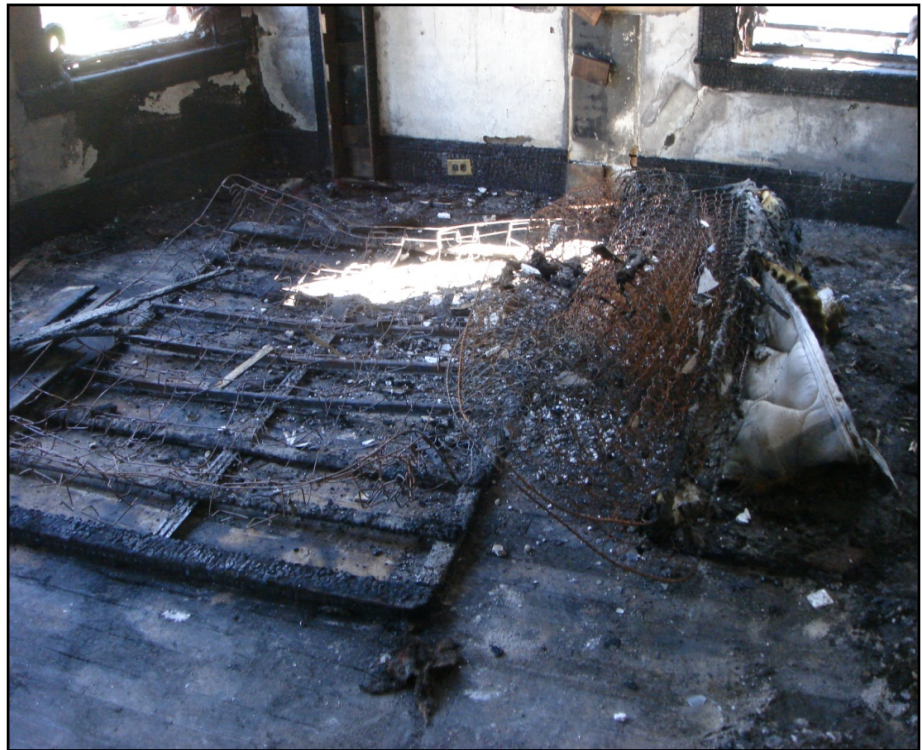
The room and contents fire was determined to have originated in a bedroom on the 2nd floor, A/B corner; it was quickly knocked down by E3 (see Photo 2). It is believed that the fire got into the eaves when it was lapping out the A/B corner windows, and then spread within the large void spaces in the ceiling and walls of the 3rd floor. The fire was situated toward the A/B corner of the 3rd floor, but the open void areas allowed smoke to accumulate within the ceilings and walls before they were opened.

**Photo 2. Remnants of a mattress and box springs within the room of origin on the 2nd floor.
(NIOSH photo.)**

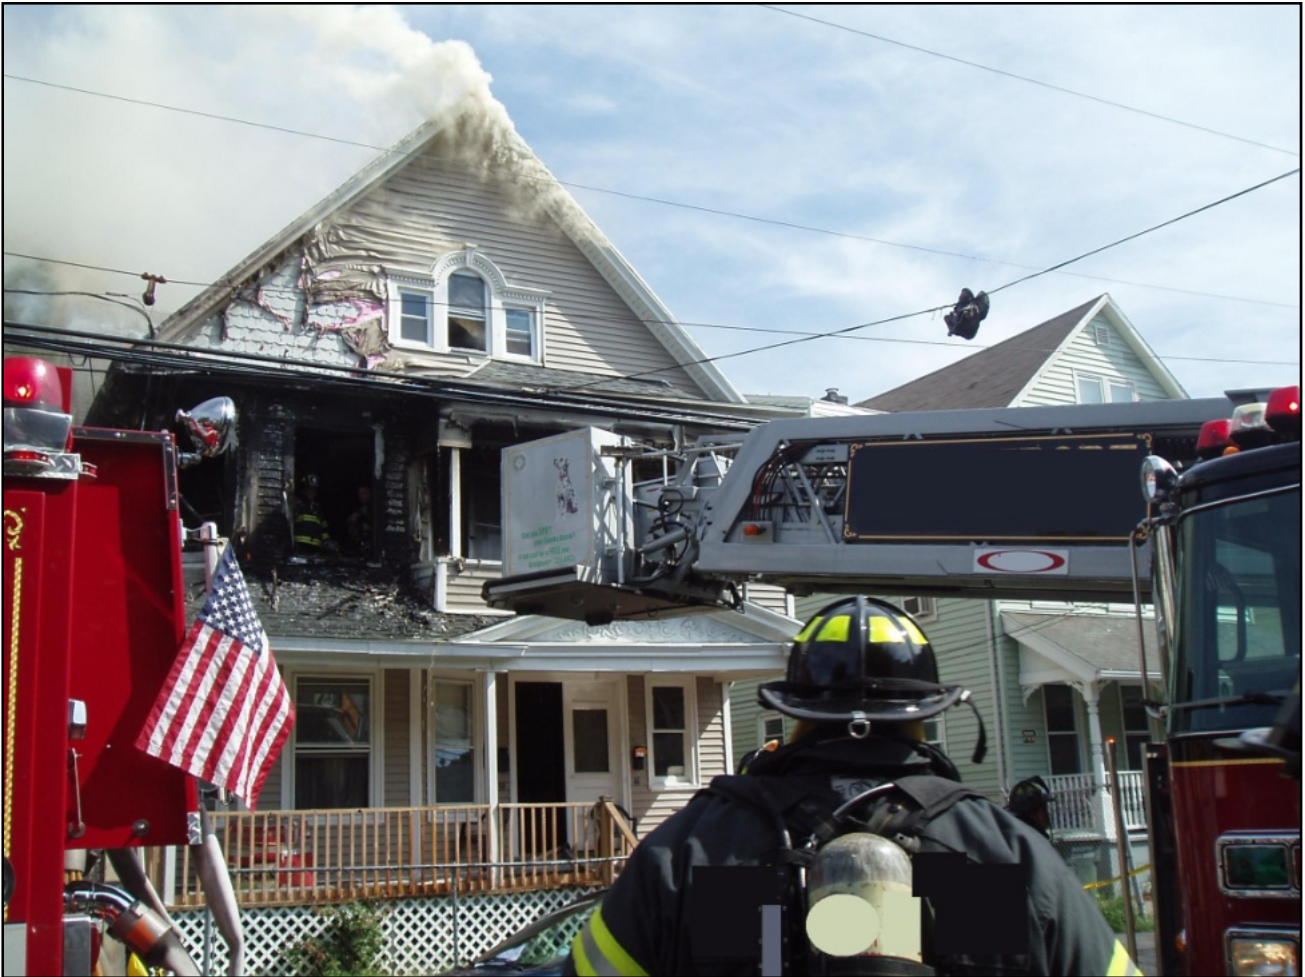
Photo 3. Initial conditions observed when the BC arrived on scene at approximately 1551 hours.
Note: Fire was under control on the 2nd floor and fire fighters were checking for extension. White-to-gray smoke can be seen flowing in the direction of right to left from the gables. The A-side window on the 3rd floor had been opened for ventilation (unsure at what stage of the fire or by whom).
(Photo courtesy of fire department.)

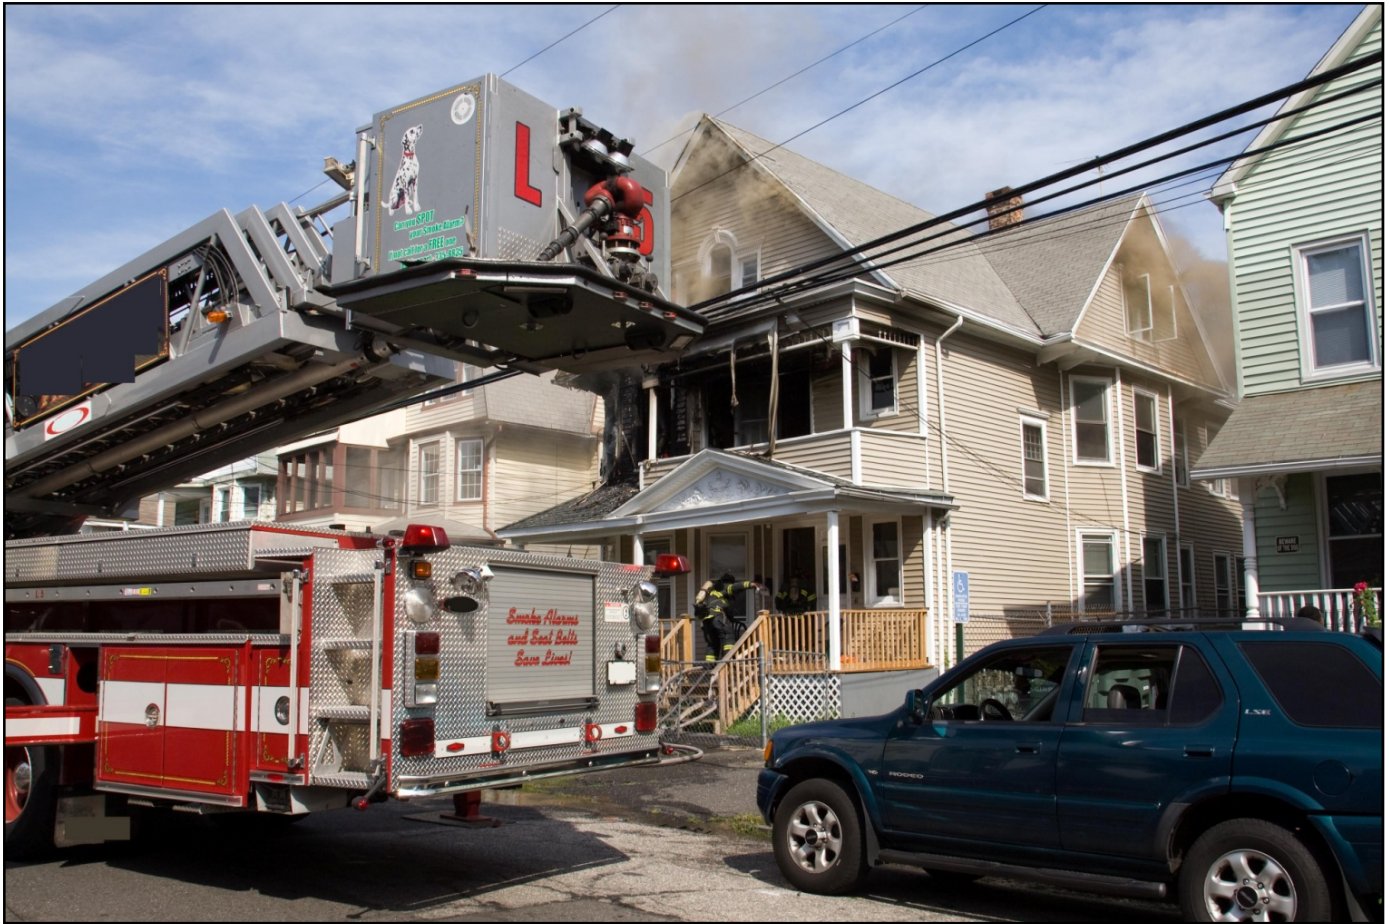
Photo 4. Conditions observed at 1608 hours by an off-duty fire fighter. *Note: Smoke had changed to gray and brown in color and was emitting from the eaves and A- and D-side windows which were manually opened by personnel working on the 3rd floor. A hoseline was being stretched to the 3rd floor.*

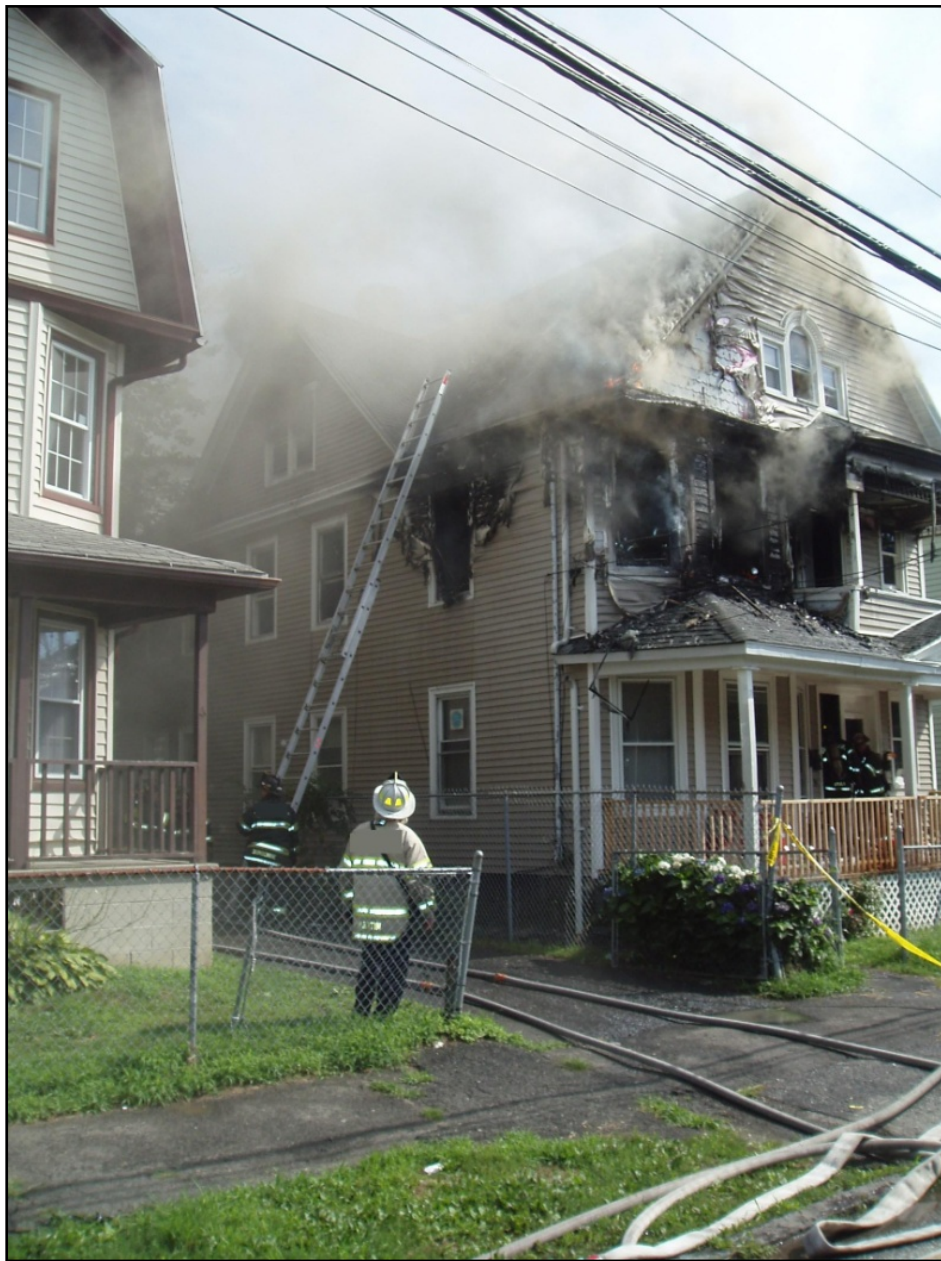
Photo 5. Conditions at approximately 1609 hours. *Note: L5 personnel were preparing to ascend the ladder placed on the B-side of the house. The IC (white helmet) is observing the scene. Smoke seen coming from the 3rd floor B-side double window and pushing from the eaves. At this time, ceiling and walls were likely being opened on the 3rd floor, and water would have been available.*
(Photo courtesy of fire department.)

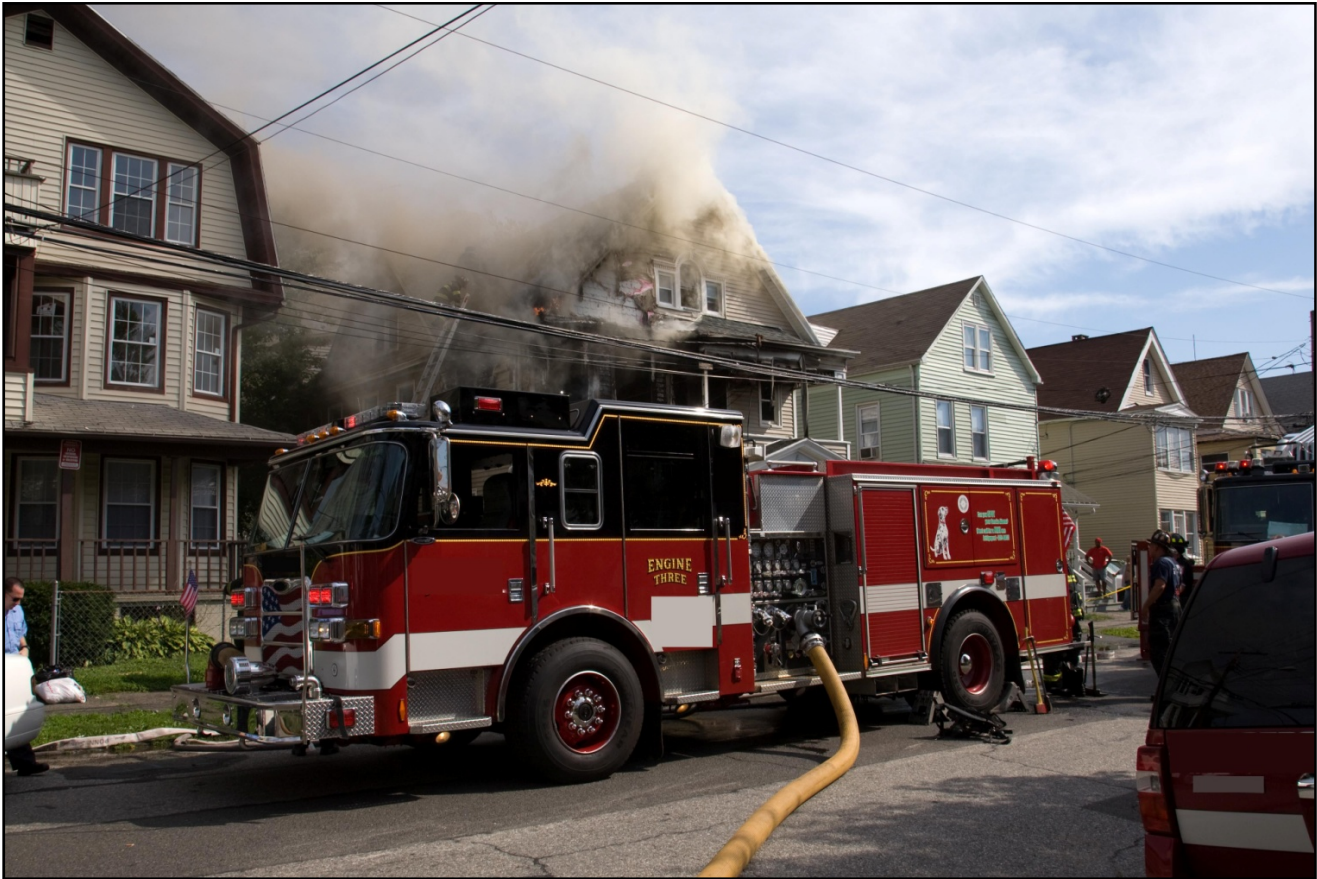
Photo 6. Conditions at approximately 1611 hours. *Note: L5 personnel were ascending the roof from the ground ladder on the B-side. Smoke color was still gray to brown in color and was becoming denser. Personnel were still working on the 3rd floor. Wind direction was right to left.*
(Photo courtesy of Keith Muratori.)

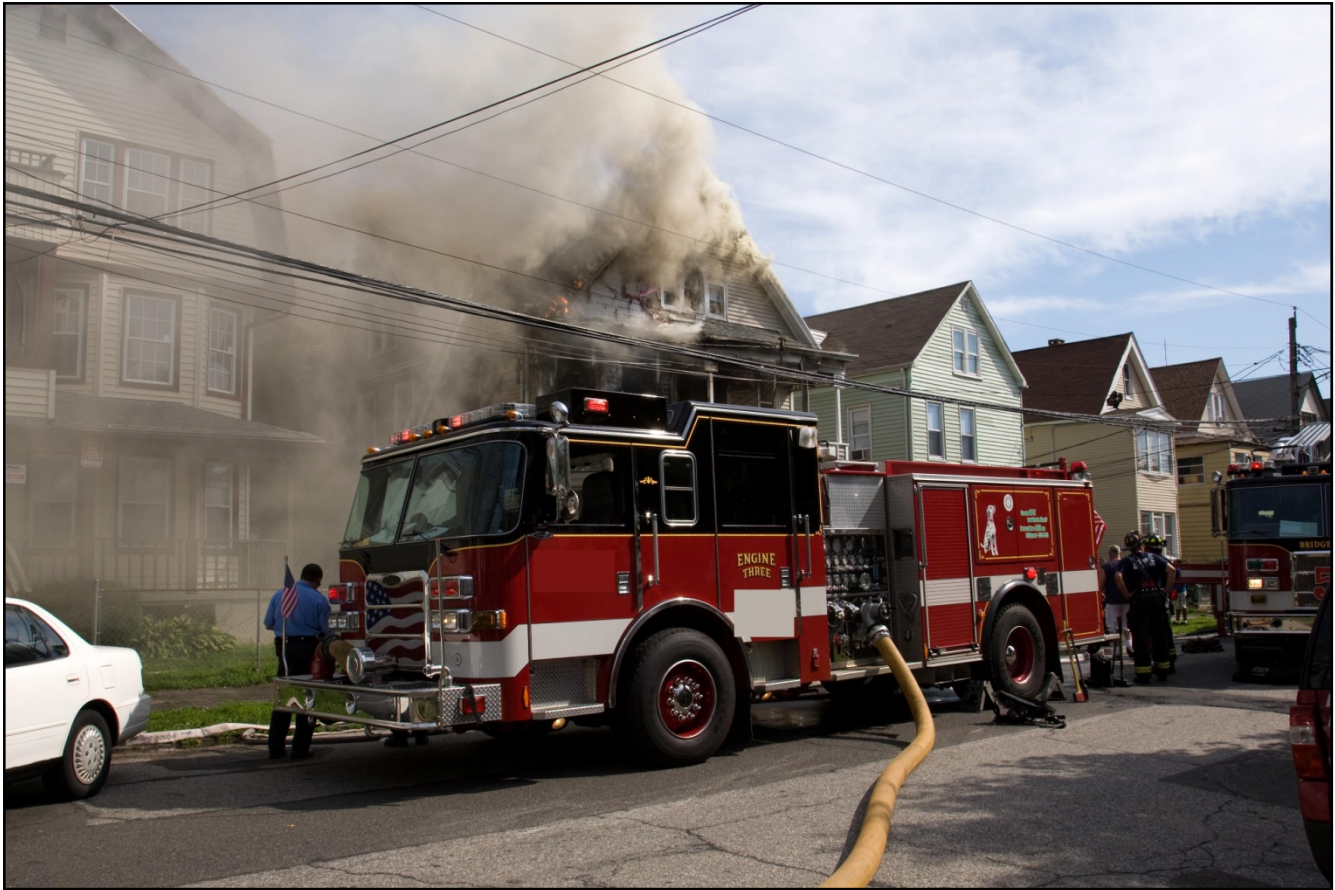
Photo 7. Conditions at approximately 1613 hours. *Note: L5 personnel were on the peak of the roof and having difficulty starting the roof saw. Smoke was denser than before and pushing from the roof and eaves. The fire fighters were unable to vent the roof. NIOSH investigators believe that Victim #1 transmitted his Mayday about this time.*
(Photo courtesy of Keith Muratori.)

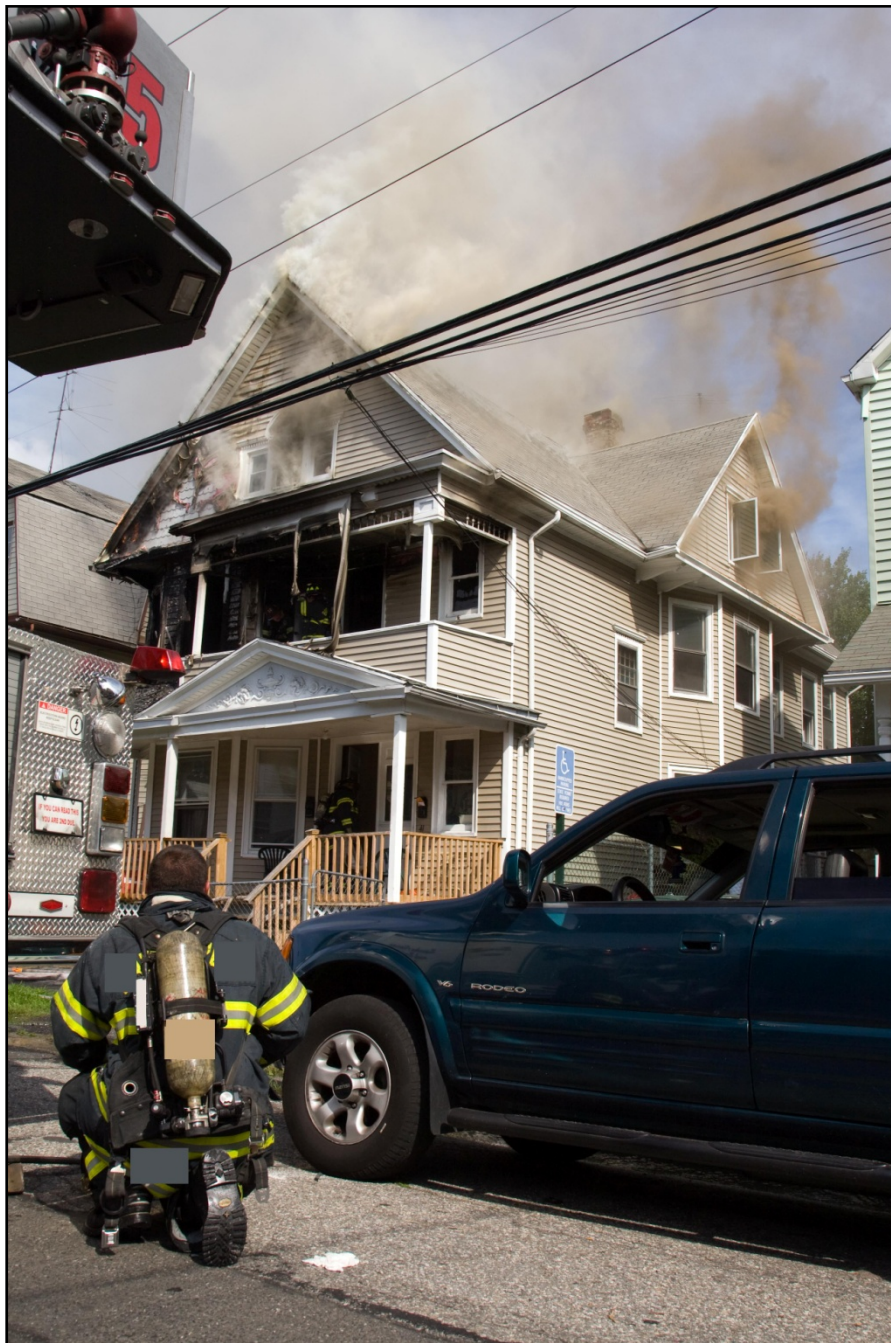
Photo 8. Conditions at approximately 1616 hours. *Note: View from the A/D corner, scene conditions very close to when FF2 discovered FF1 pulling Victim #1 off the 3rd floor stairs. White and gray smoke can be seen flowing from the A-side window and eaves while brown smoke flowed from the D-side window.*

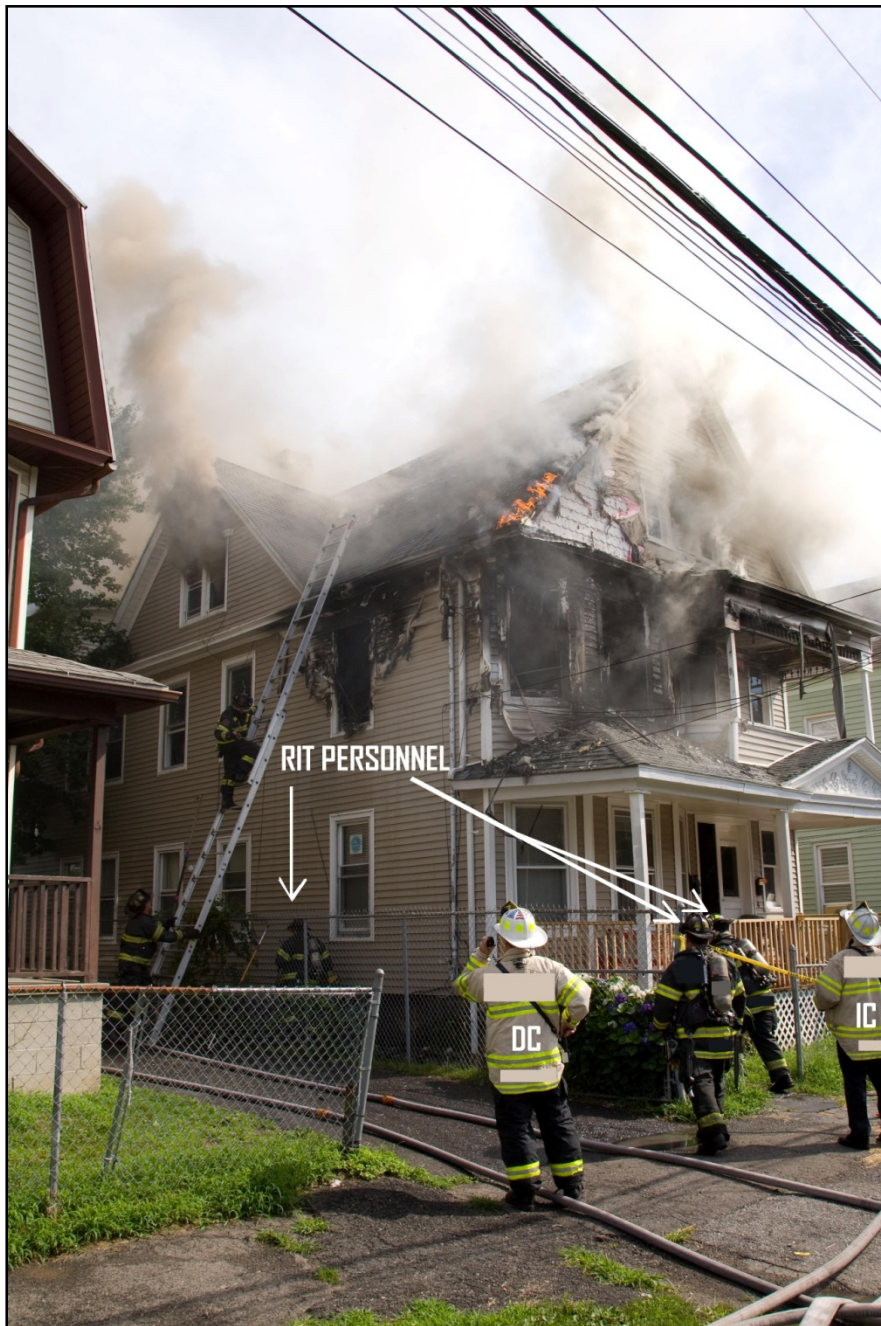
Photo 9. Mayday for Victim #1, called by FF2. *Note: RIT personnel from E12 are seen heading to the rear of the house. L5 personnel were descending the roof via the B-side ground ladder. Fire is seen burning along the roof line above the A/B corner. Gray, dense smoke was flowing from the 3rd floor B-side double window and A-side window.*
(Photo courtesy of Keith Muratori.)

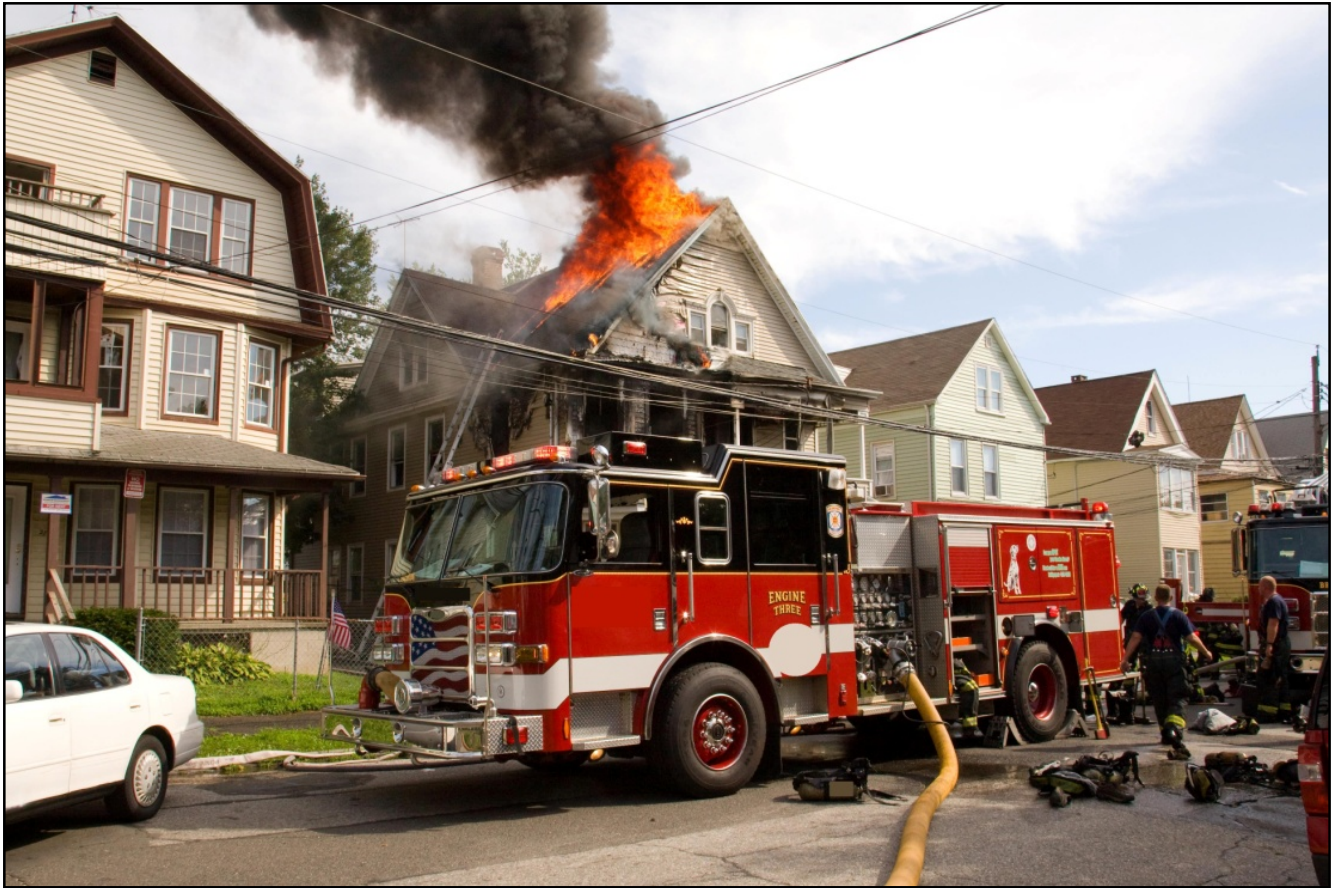
Photo 10. Fire vented through the roof. *Note: NIOSH investigators believe this photo shows conditions very close to the time that the Mayday was called for Victim #2 by FF4. Wind was pushing the smoke plume from right to left.*
(Photo courtesy of Keith Muratori.)

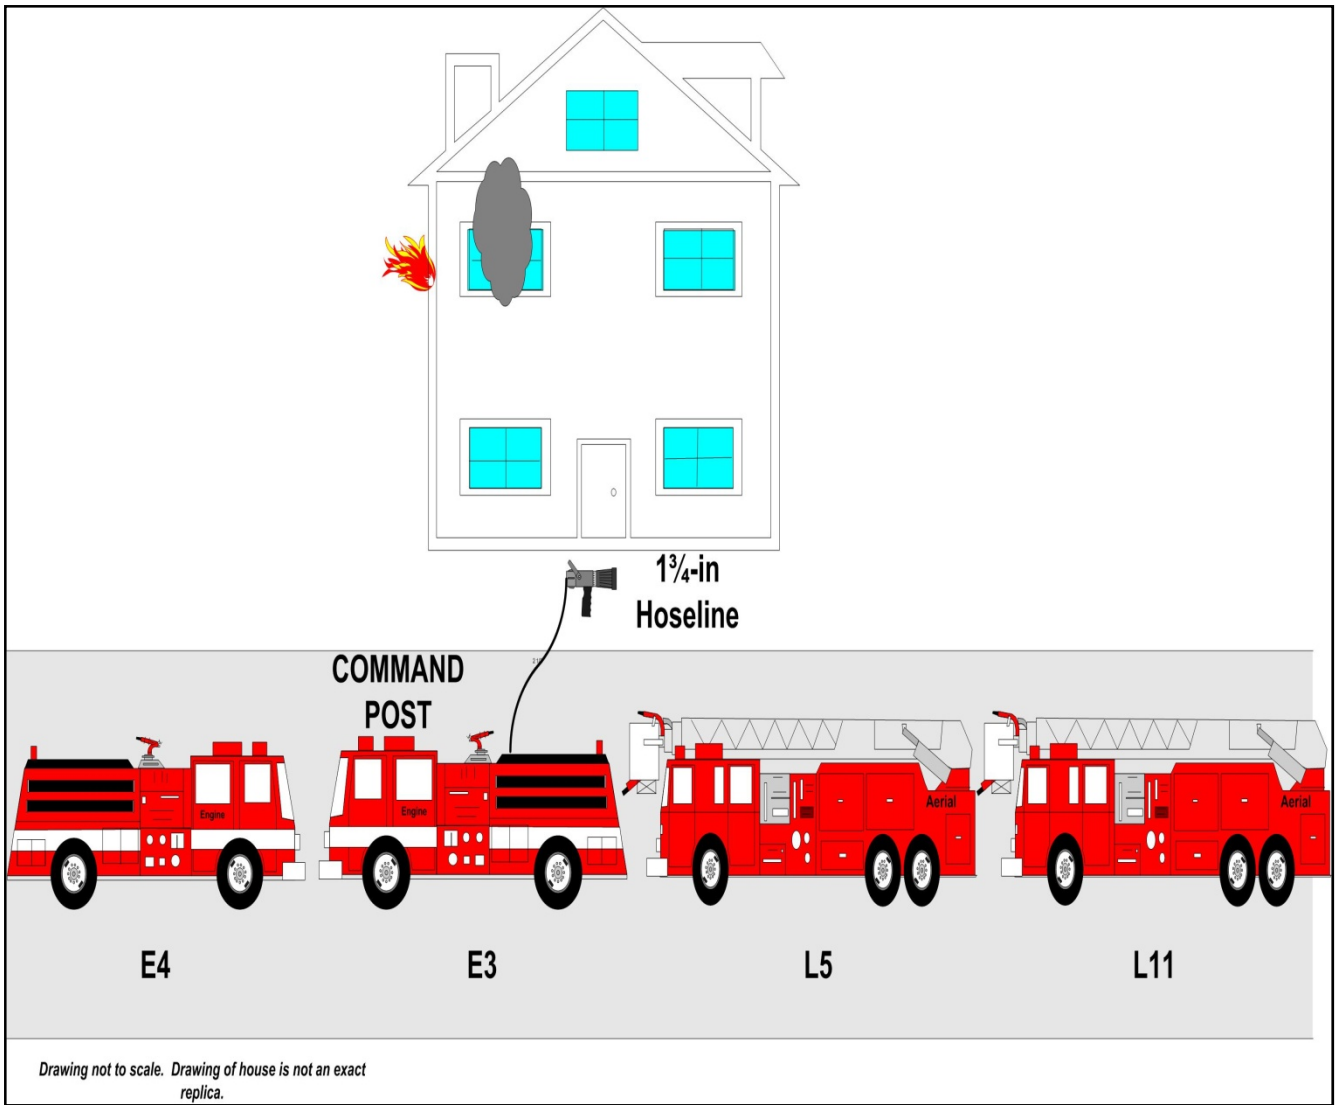
Diagram 1. Initial conditions and fire apparatus on scene. *Note: E4 and L11 arrived on scene after the initial room and contents fire was brought under control.*

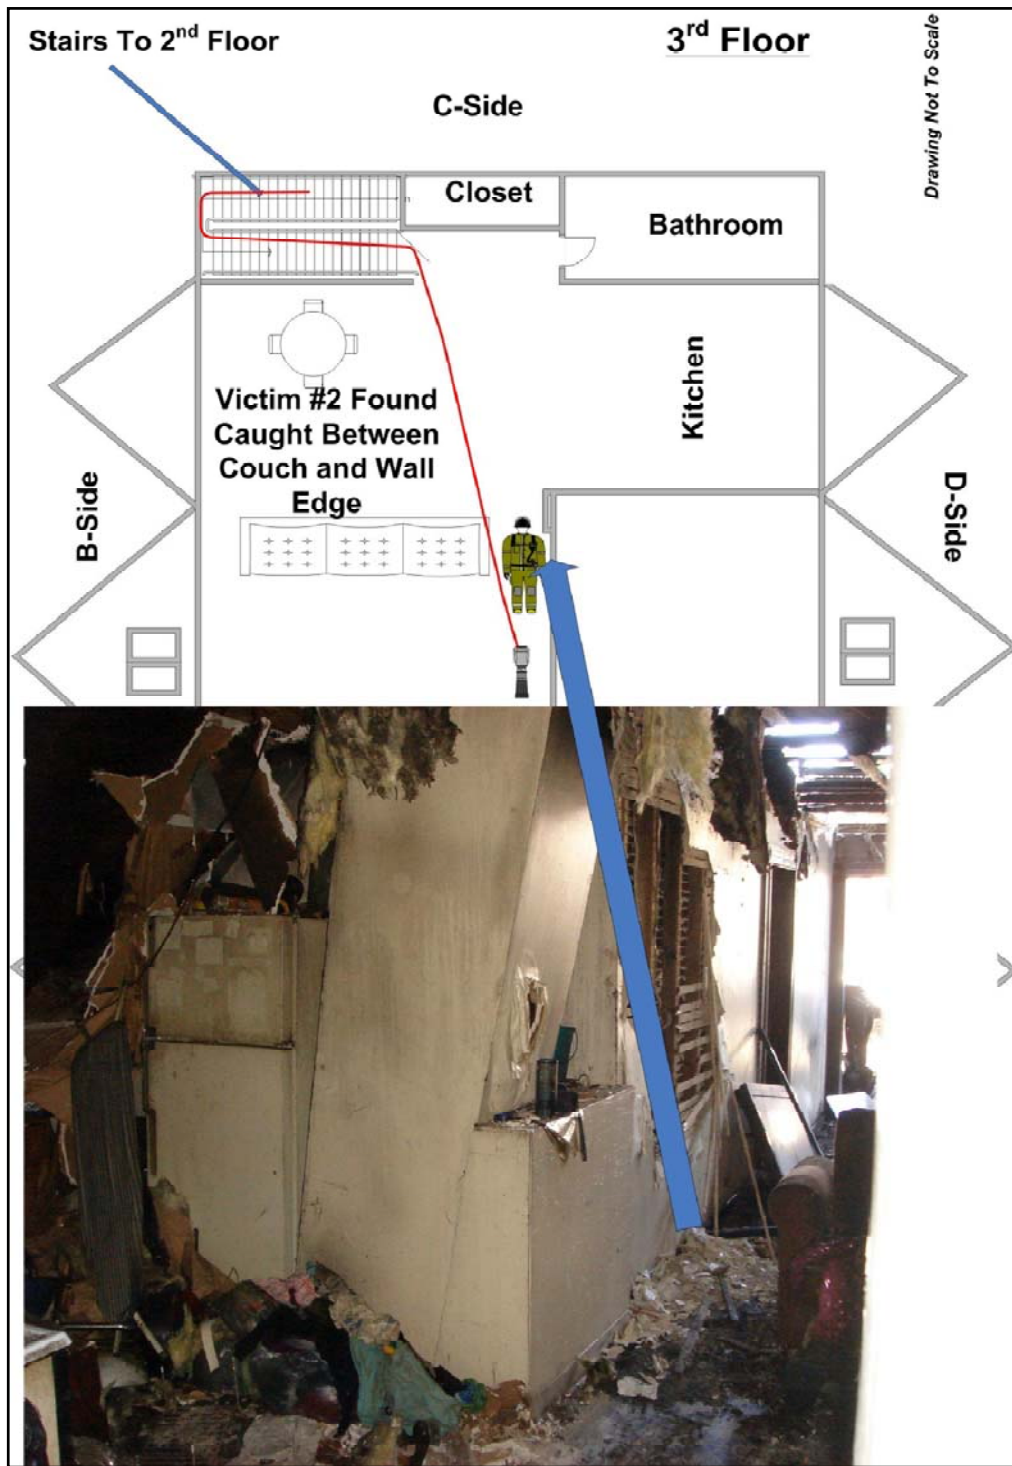
Diagram 5. Shows location of where Victim #2 was found by FF4. *Note: Orientation of the picture differs from the diagram.*
