Career Fire Fighter Dies From an Out-of-air Emergency in an Apartment Building Fire—Connecticut

Executive Summary

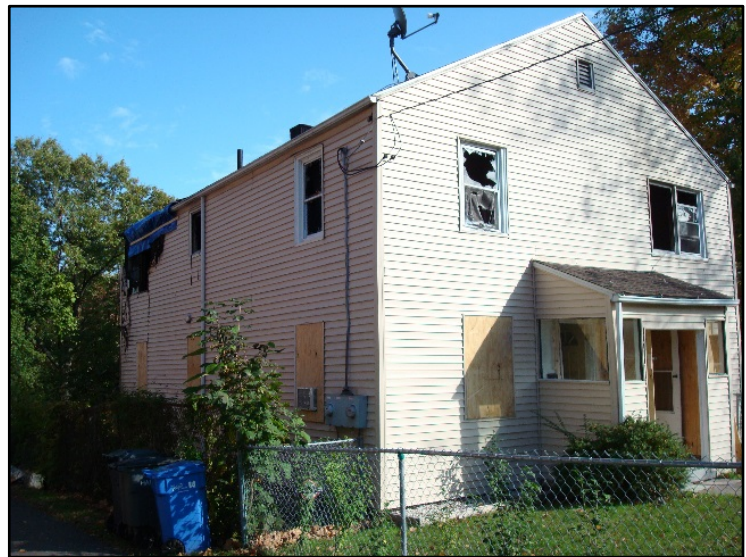
**Sides Alpha and Bravo of the fire building
(NIOSH photo.)**

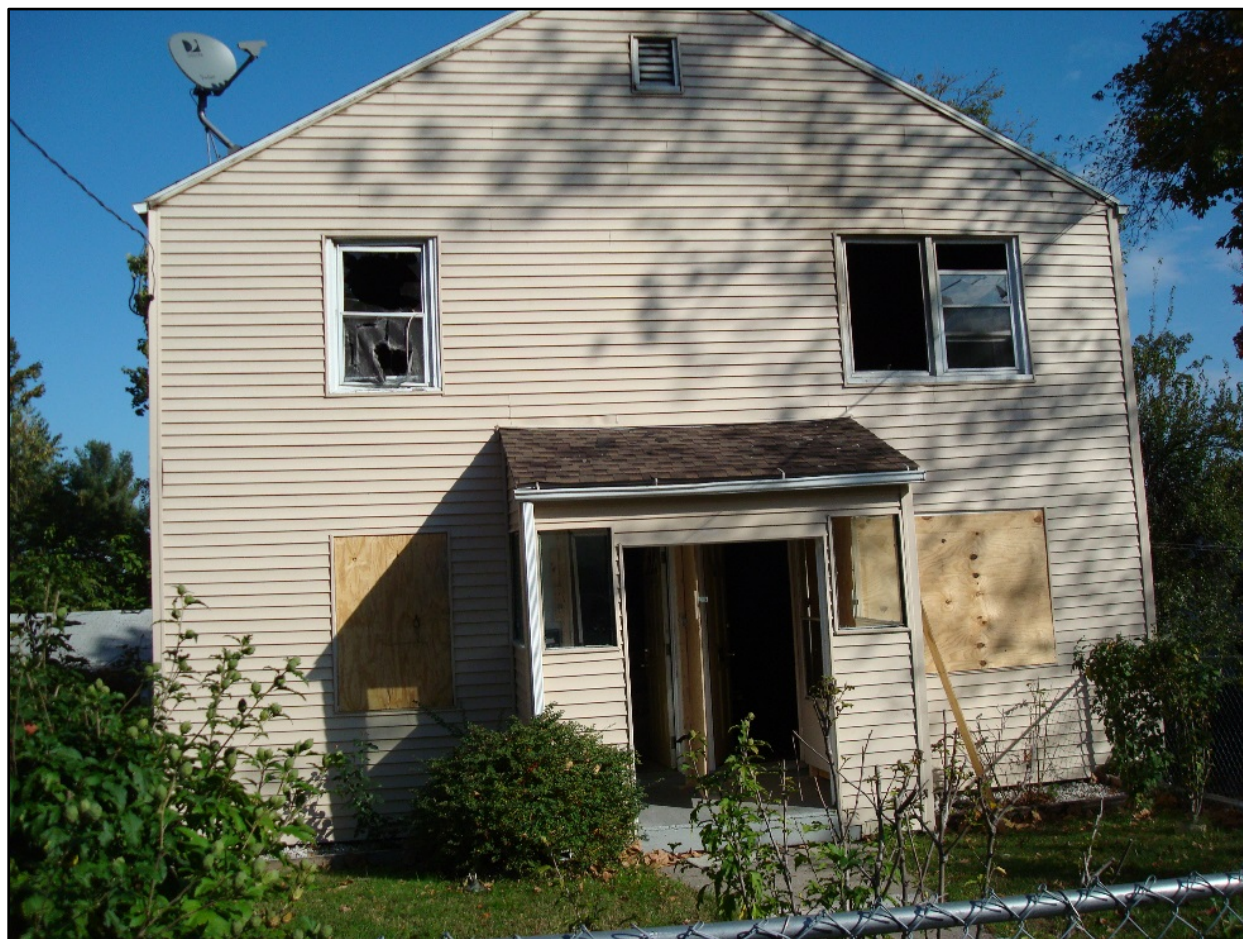
Photo 1. Side Alpha—street view of the duplex. Engine 16 and Ladder 4 made entry into the building through the left doorway.
(NIOSH photo.)

The two-story apartment building was built in 1953 and constructed of a wood frame on a poured concrete basement foundation (see Photos 1–4). The two-story structure consisted of 2,016 square feet of total living space between the two apartments. Each floor consisted of five rooms that included two bedrooms, a living room, a kitchen, and a bathroom. The exterior was covered with vinyl siding, and the pitched roof was covered with asphalt shingles. The structure had a front entrance with two doors: the one on the left opened to an interior stairway to the second floor, and the one on the right to the first-floor apartment. At the top of the stairway was a door with a dead bolt and a second door to the right with a normal entry knob. There was a rear entrance to both floors via a covered porch with stairs to the second floor. The structure had an unoccupied third apartment in the finished basement with an exterior entrance in the rear (Side Charlie) of the structure. The building's utilities were electric and natural gas heating.

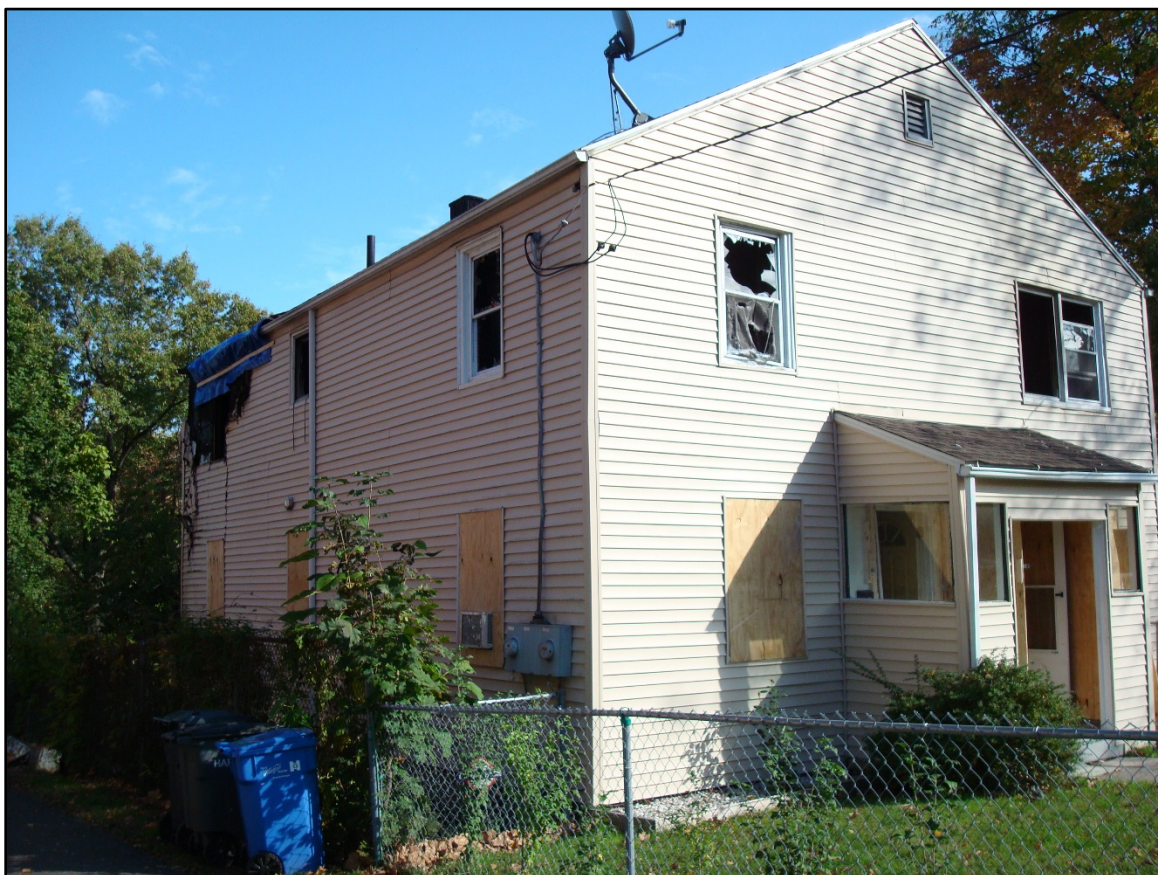
Photo 2. Side Bravo—street view of the duplex. Origin of fire near the Bravo/Charlie corner on the second floor.
(NIOSH photo.)

The origin and cause of the fire is still under investigation by the Connecticut State Police's Fire and Explosion Investigation Unit. By all accounts, the fire originated on the second floor, in the bedroom on the Bravo/Charlie corner of the fire structure.

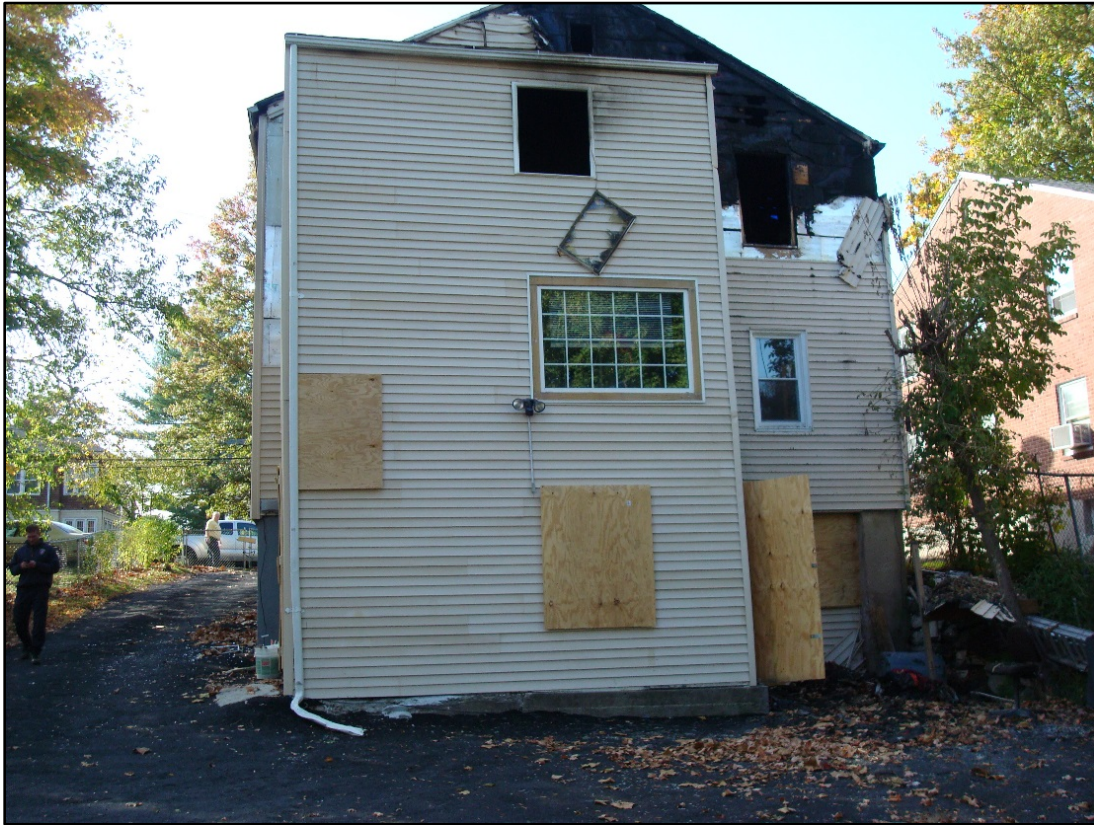
Photo 3. Side Charlie of the structure. An unoccupied apartment was in the basement. The entrance to the basement apartment is on the Bravo/Charlie corner.

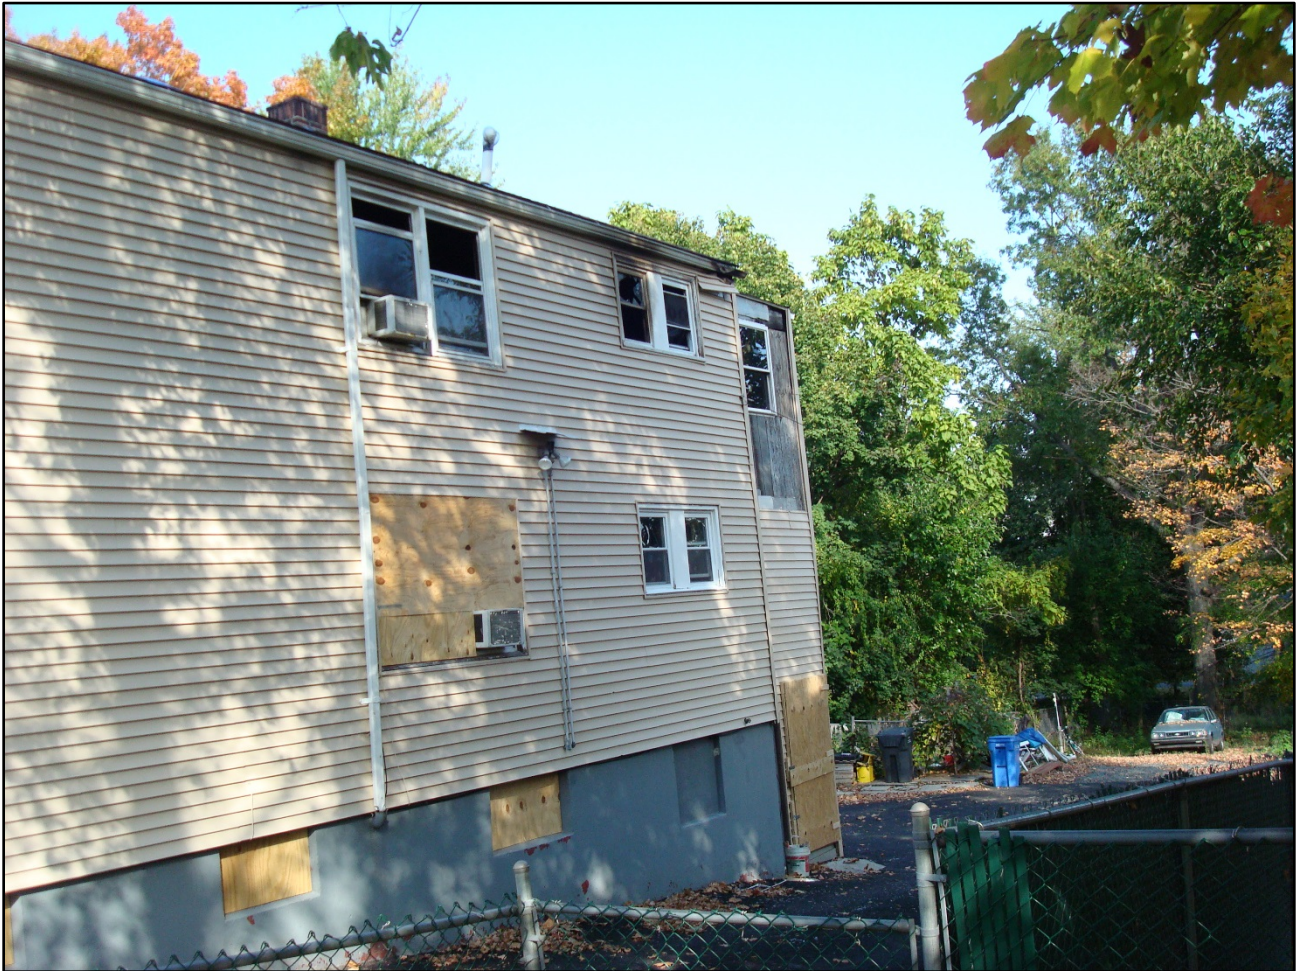
Photo 4. Side Delta of the structure. A rear entrance leads to the first- and second-floor apartments on the Delta/Charlie corner
(NIOSH photo.)
