## **Career Fire Fighter Dies during Fire-Fighting Operations at a Multi-family Residential Structure Fire - Massachusetts**

### **Executive Summary**

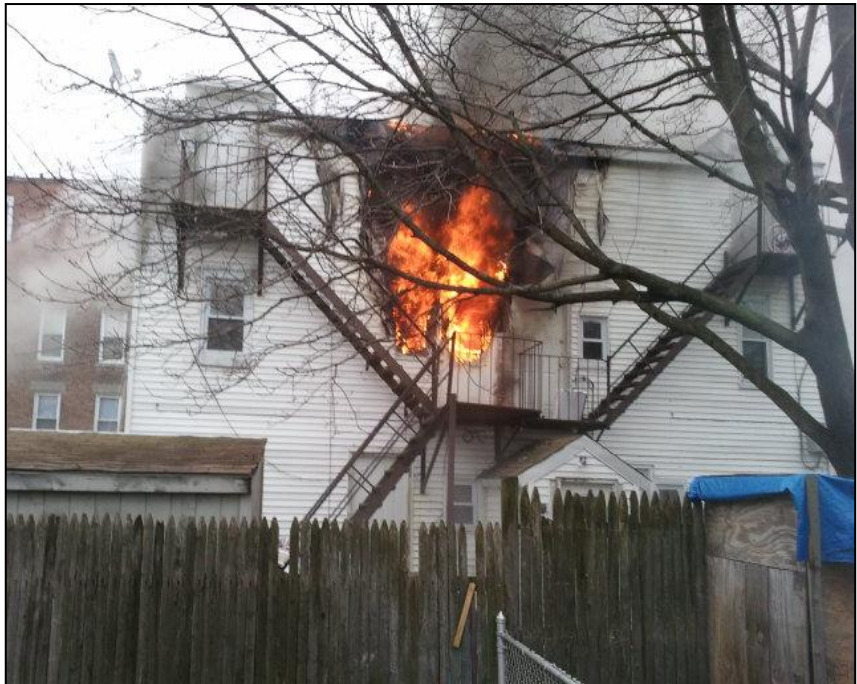
**View of the fire building from Side "C" during the initial stages of the fire as Engine 5 was entering from Side "A".**

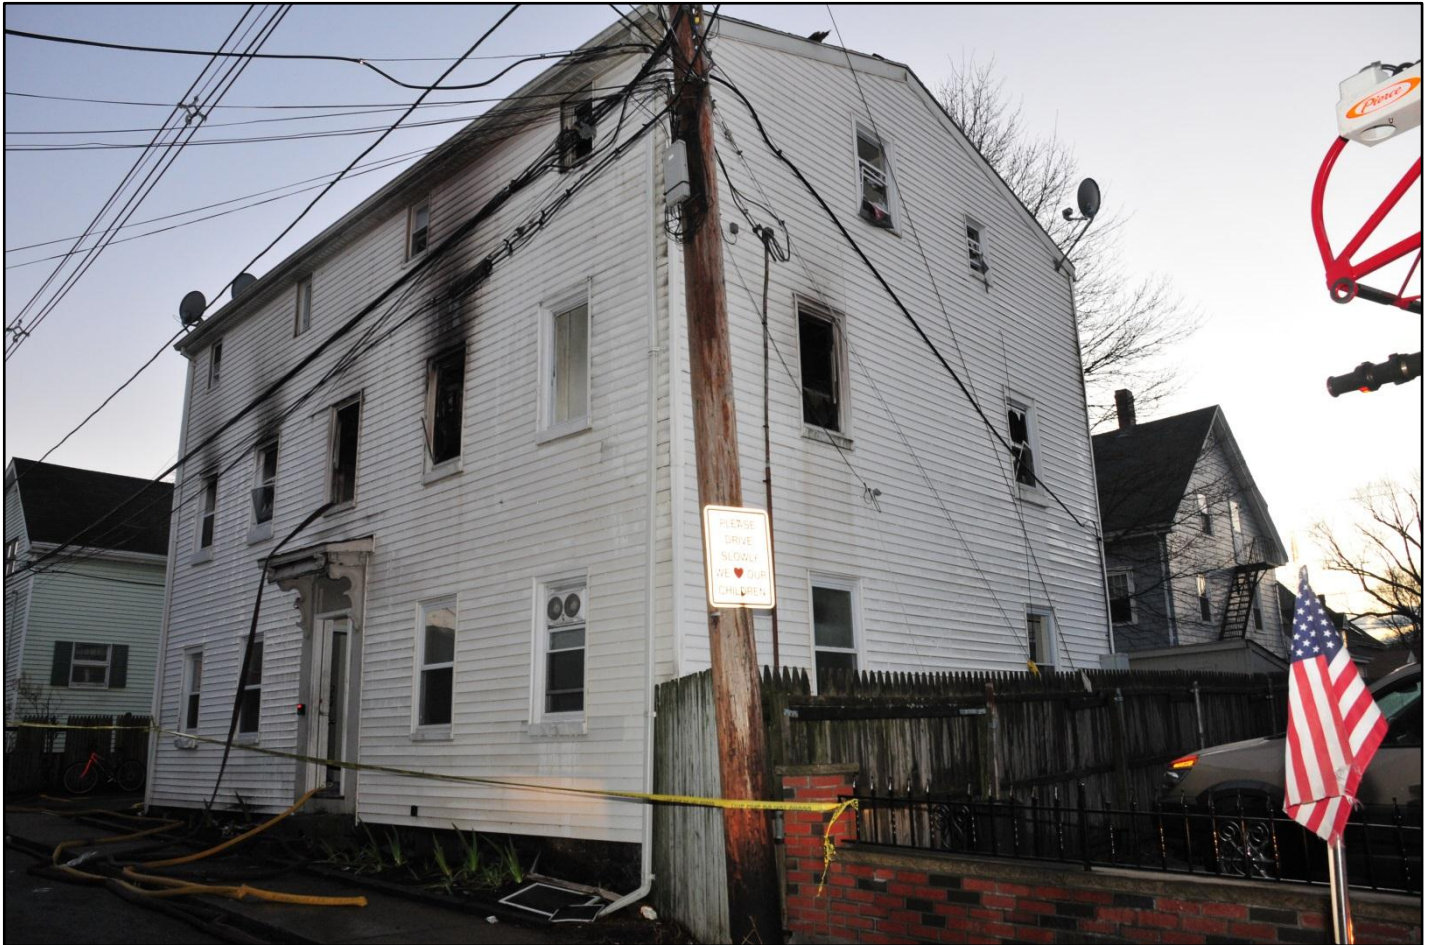
**Photo 1. The apartment building viewed from the “A/D” corner.  
The window above the doorway is the hallway landing on the 2nd floor.**

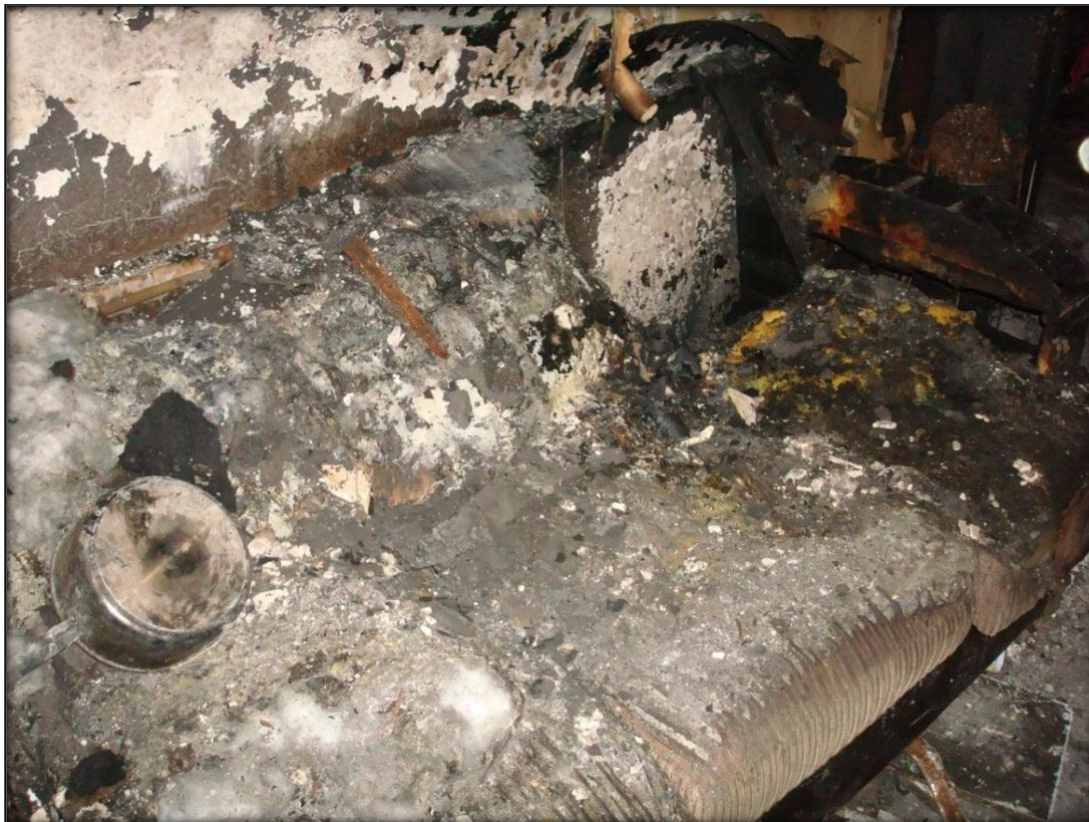
**Photo 2. The pan that the female occupant used to attempt to extinguish the fire in the bedroom. The couch is located on the wall against the stairwell.**

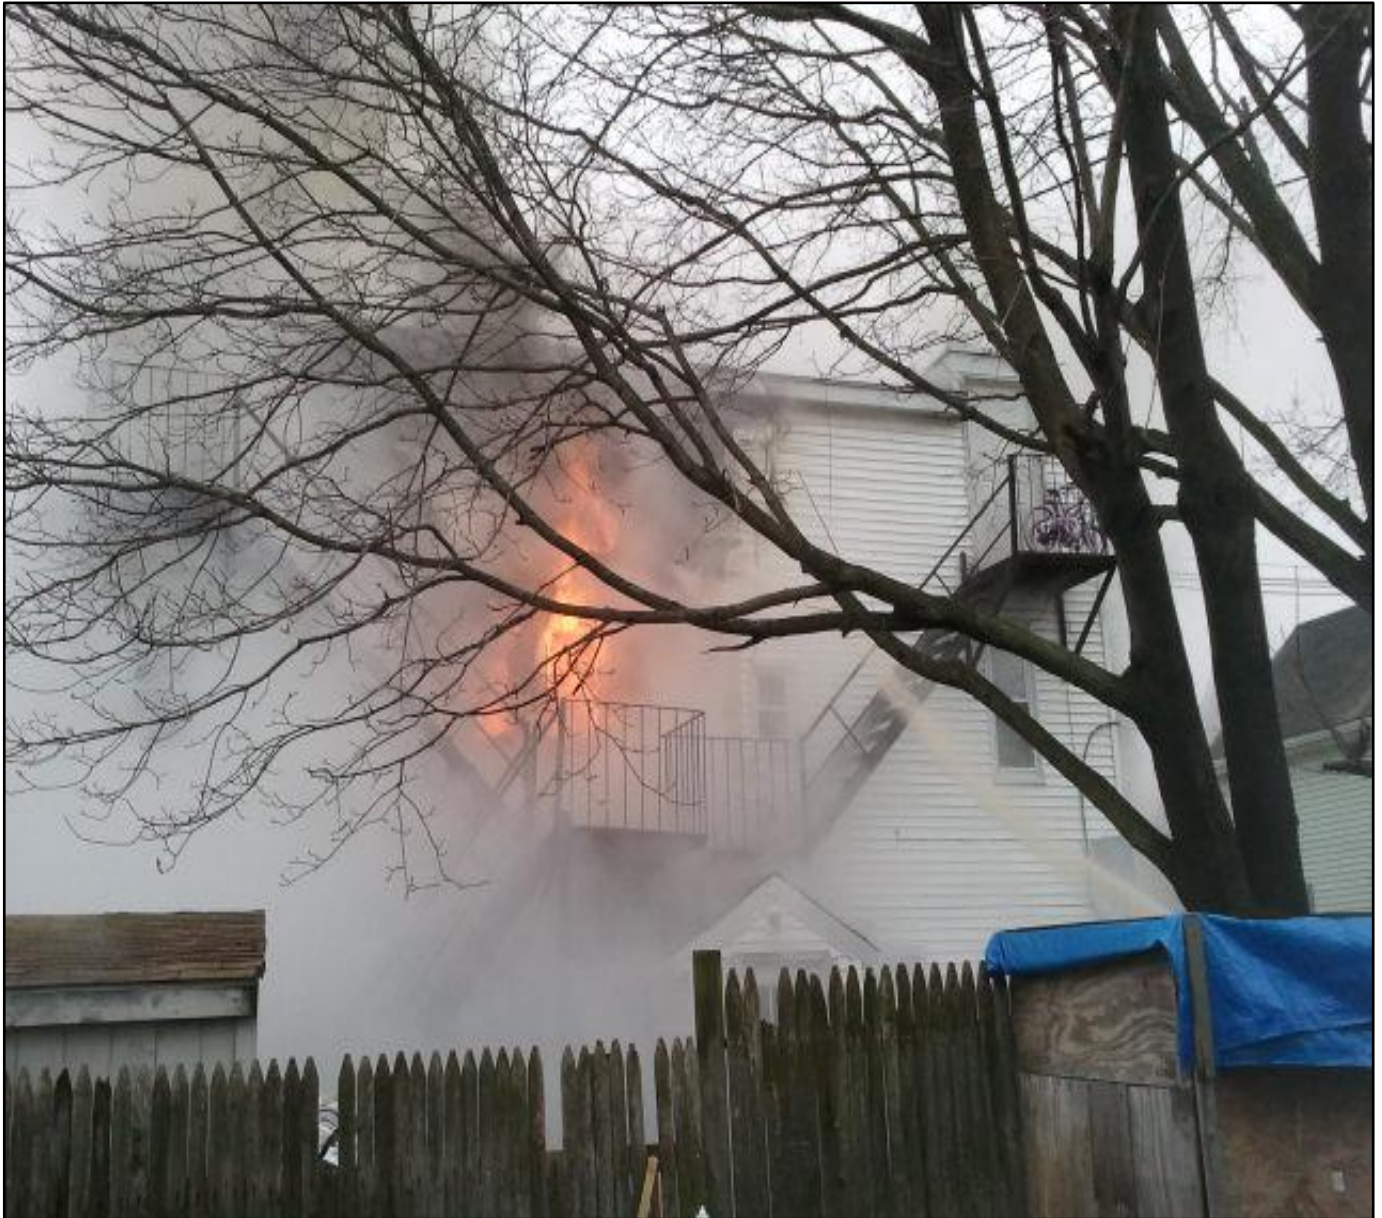
The driver/operator of Ladder 1 had pulled a 1¾” handline to Side “C” to knock down the fire which was extending from the 2<sup>nd</sup> floor bedroom window to the 3<sup>rd</sup> floor (**See Photo 3**). Ladder 1 went back to search on the 3<sup>rd</sup> floor and attempted to take out the skylight that was located on the 3<sup>rd</sup> floor landing. The officer of Ladder 1 reported high heat conditions and very poor visibility on the 3<sup>rd</sup> floor.

**Photo 3. The driver/operator of Ladder 1 operating a hoseline from Side “C”. The Incident Commander ordered the driver/operator to knock down the fire which was spreading from the 2<sup>nd</sup> floor to the 3<sup>rd</sup> floor. This hoseline, from Engine 5, was operated due to the delay in Engine 5 getting water on the fire. The time was approximately 1334 hours.**

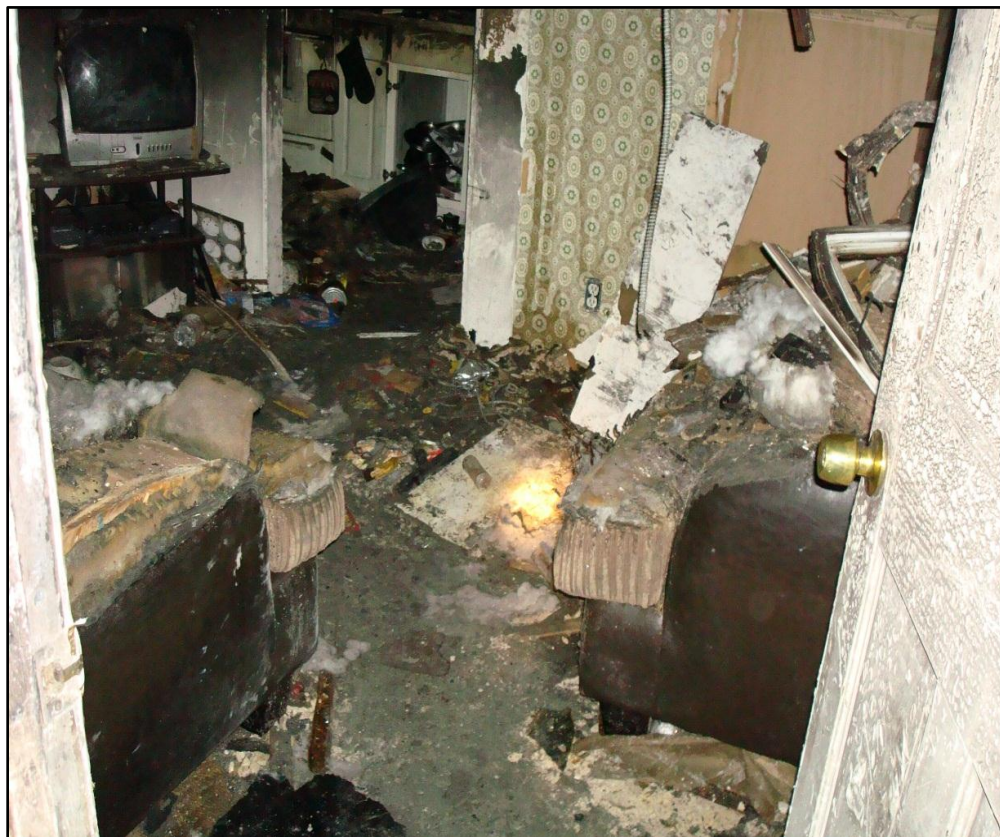
**Photo 4. A view of the living room of the fire apartment from the doorway. The location of the two couches created ingress and egress problems for fire fighters. The victim was found in the kitchen near the entrance to the 2<sup>nd</sup> bedroom**
